APPENDIX B

Outfall Screening Reports

Monongahela River Outfall Screening Reports

MS4 OUTFALL FIELD SCREENING REPORT

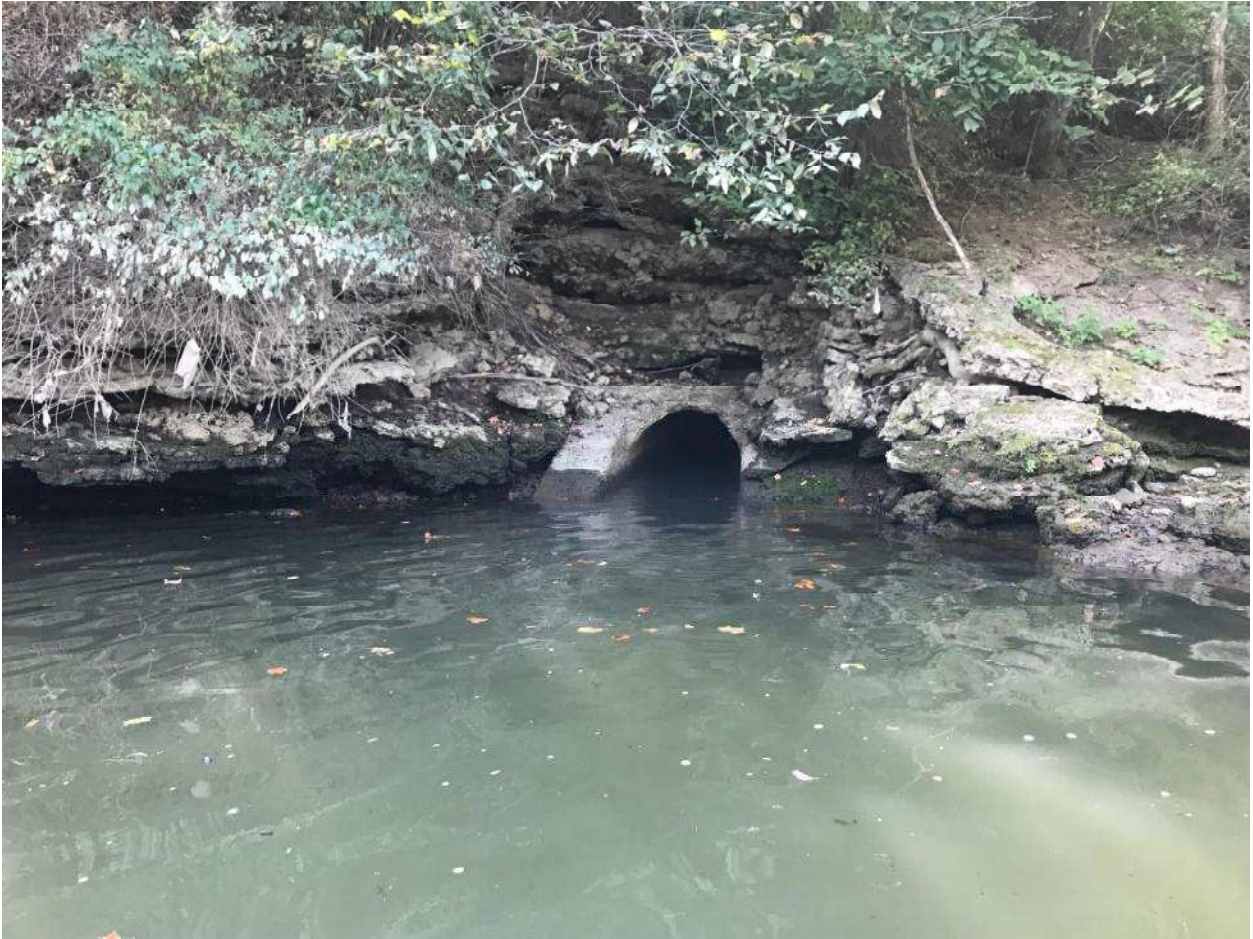
Outfall #CS003 of the Monongahela River

Does the dry weather flow contain an odor? Yes No If Yes, provide a description below.
Strong sewage odor present

Does the dry weather flow contain floating solids, scum, sheen or substances that result in deposits? Yes No
If Yes, provide a description below.
Steam present above flow within outfall

Sewage flow present, but further coordination with MVSA is necessary to determine cause, severity and origin.

Outlets to the Monongahela River. Unable to measure the pipe because the screening was performed from a small boat in the river. Outfall partially submerged within water from adjacent river. Moderate flow during inspection with strong sewage odor and steam present at outfall. No erosion at outfall, but sediment deposition evident within river. Recommend further coordination with MVSA to determine origin of sewage flow and performing future inspections in the spring prior to heavy foliage and marking the location of the outlet pipe on top of the embankment.

36" RCP (potential illicit discharge)

Coordination with MVSA must occur

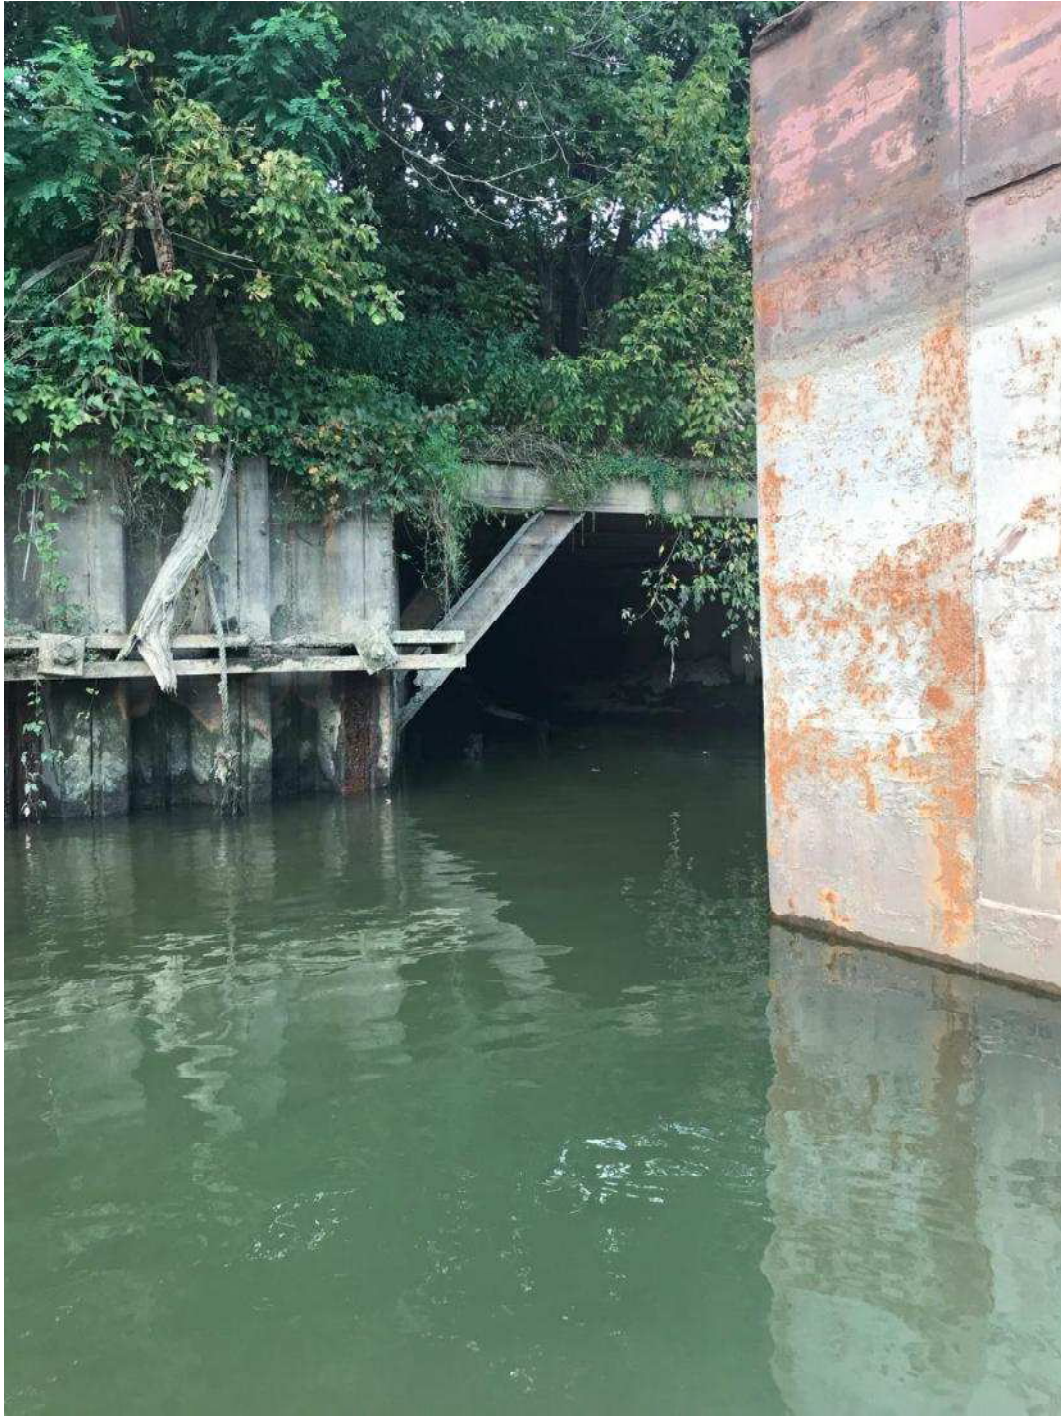
Outfall #CS004 of the Monongahela River (outfall obscured by parked barge)

Does the dry weather flow contain an odor? Yes No If Yes, provide a description below.
Strong sewage odor present

Sewage flow present, but further coordination with MVSA is necessary to determine cause, severity and origin.

Large brick arch outlets to the Monongahela River. Unable to measure the pipe because the screening was performed from a small boat in the river and large barges docked in front of outfall. Outfall partially submerged within water from adjacent river. Moderate flow during inspection with strong sewage odor present at outfall. No erosion at outfall, but sediment and debris deposition evident within river. Recommend further coordination with MVSA to determine origin of sewage flow and performing future inspections in the spring prior to heavy foliage and marking the location of the outlet pipe on top of the embankment.

Large box culvert (potential illicit discharge)

Coordination with MVSA must occur

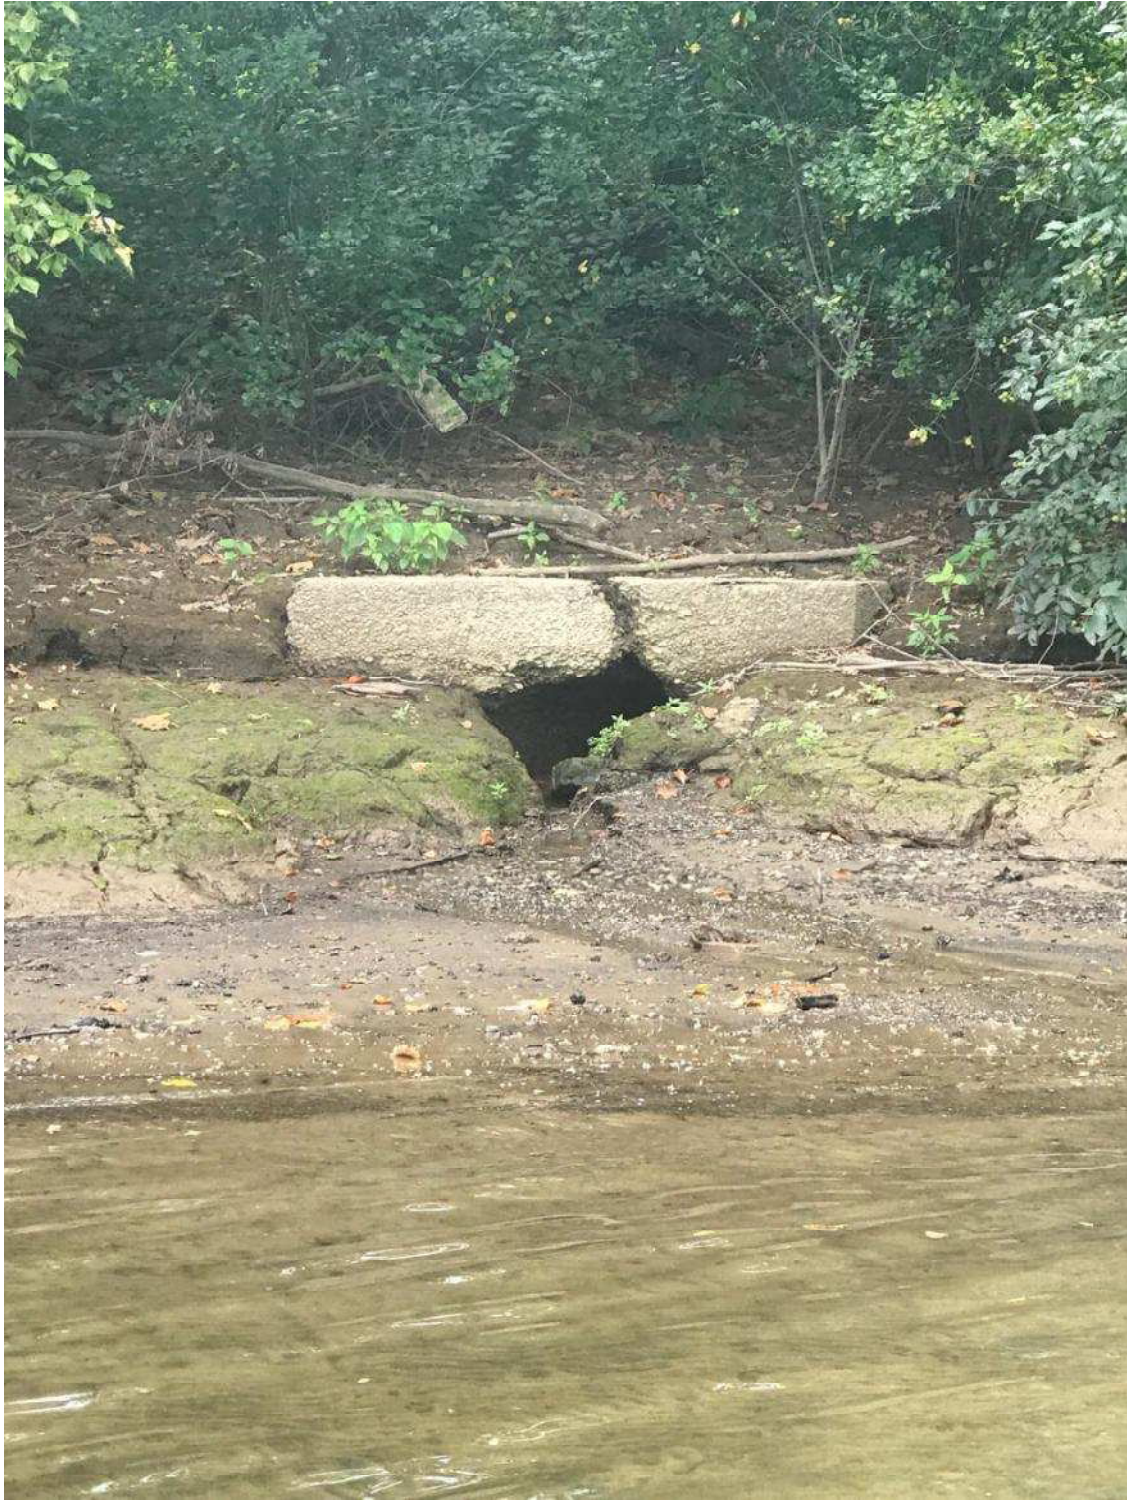
Outfall #CS006 of the Monongahela River. Note large area of sediment deposition from the river.

Outlets to the Monongahela River. Unable to measure the pipe because the screening was performed from a small boat in the river and large barges docked in front of outfall. Outfall partially submerged within water and sediment from adjacent river. Moderate flow during inspection but flow was clear with no odors. Large area of sediment and debris deposition evident within river at outfall area. Recommend performing future inspections in the spring prior to heavy foliage and marking the location of the outlet pipe on top of the embankment.

48" RCP

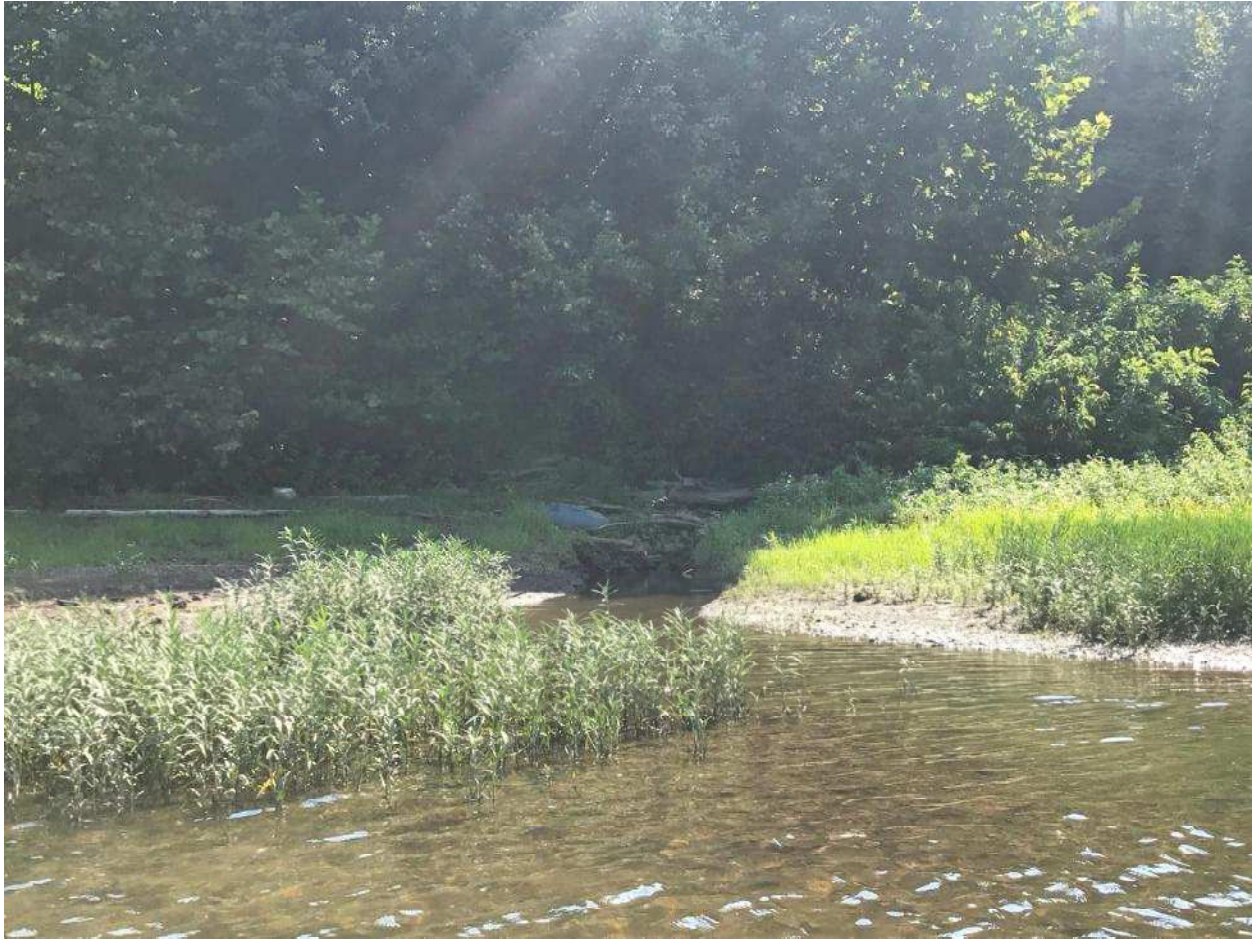
Outfall #CS101 of the Monongahela River. Note large area of sediment and debris deposition from the river.

Outlets to the Monongahela River. The screening was performed from a small boat in the river. Unable to physically measure the pipe. A recent physical inspection of the pipe 200' upstream near Riverview SR 908 reported the pipe was dry. A spring or underground stream is the likely cause for the dry weather flow observed during the screening. The flow observed was clear with no odor, but moderate in rate. The outfall was partially submerged in both sediment and water with large wood debris from the river piled at the pipe outfall. Recommend performing future inspections in the spring prior to heavy foliage and marking the location of the outlet pipe on top of the embankment.

24" RCP

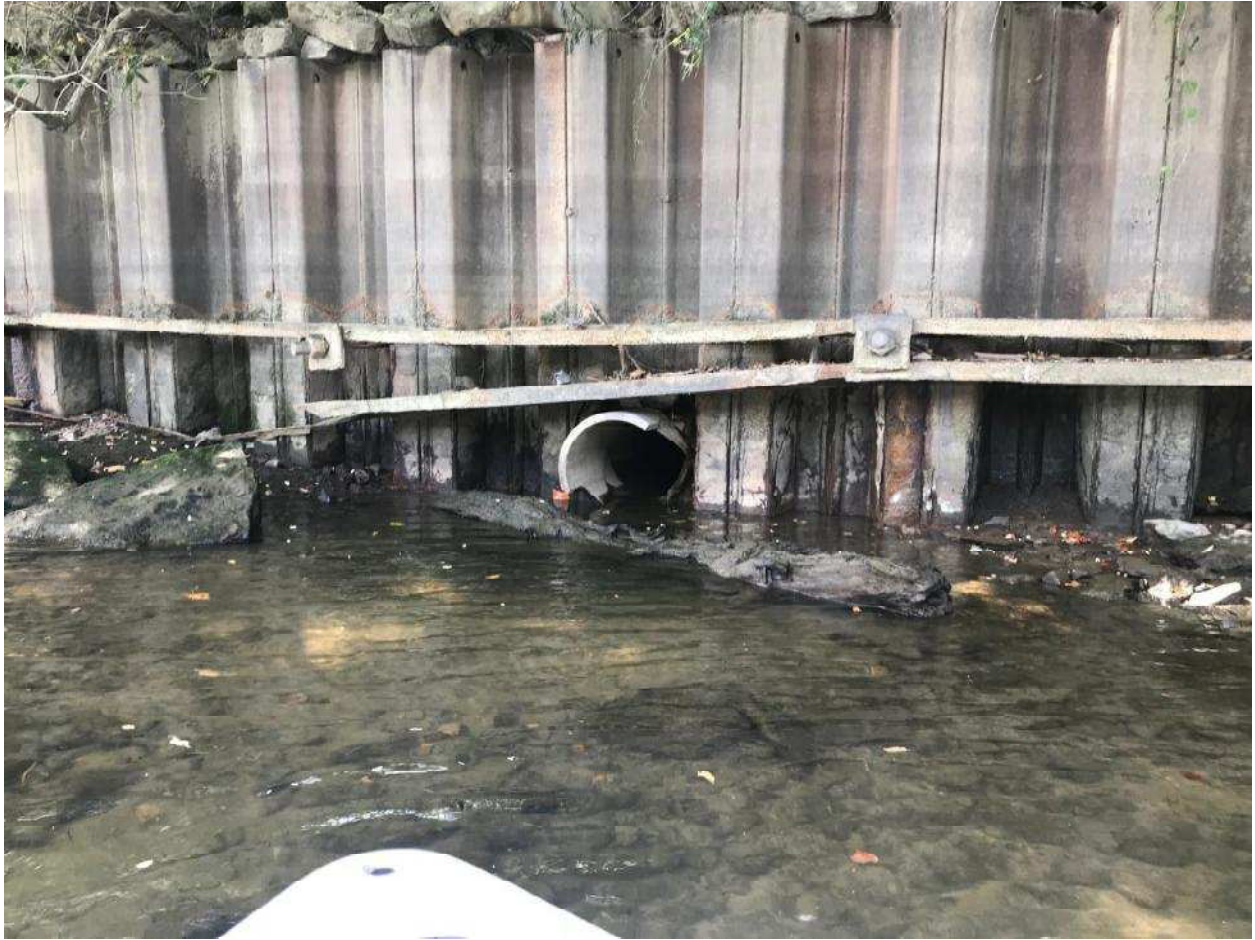
Outfall #CS102 of the Monongahela River.

Outlets to the Monongahela River. The screening was performed from a small boat in the river. Unable to physically measure the pipe. The outfall was partially submerged in water, therefore unable to determine if dry weather flow existed. Upstream pipe must be further investigated to verify flow regime within system. No erosion at outfall. Large log present from river flooding. Recommend performing future inspections in the spring prior to heavy foliage and marking the location of the outlet pipe on top of the embankment and additional flow investigation.

24" TCP

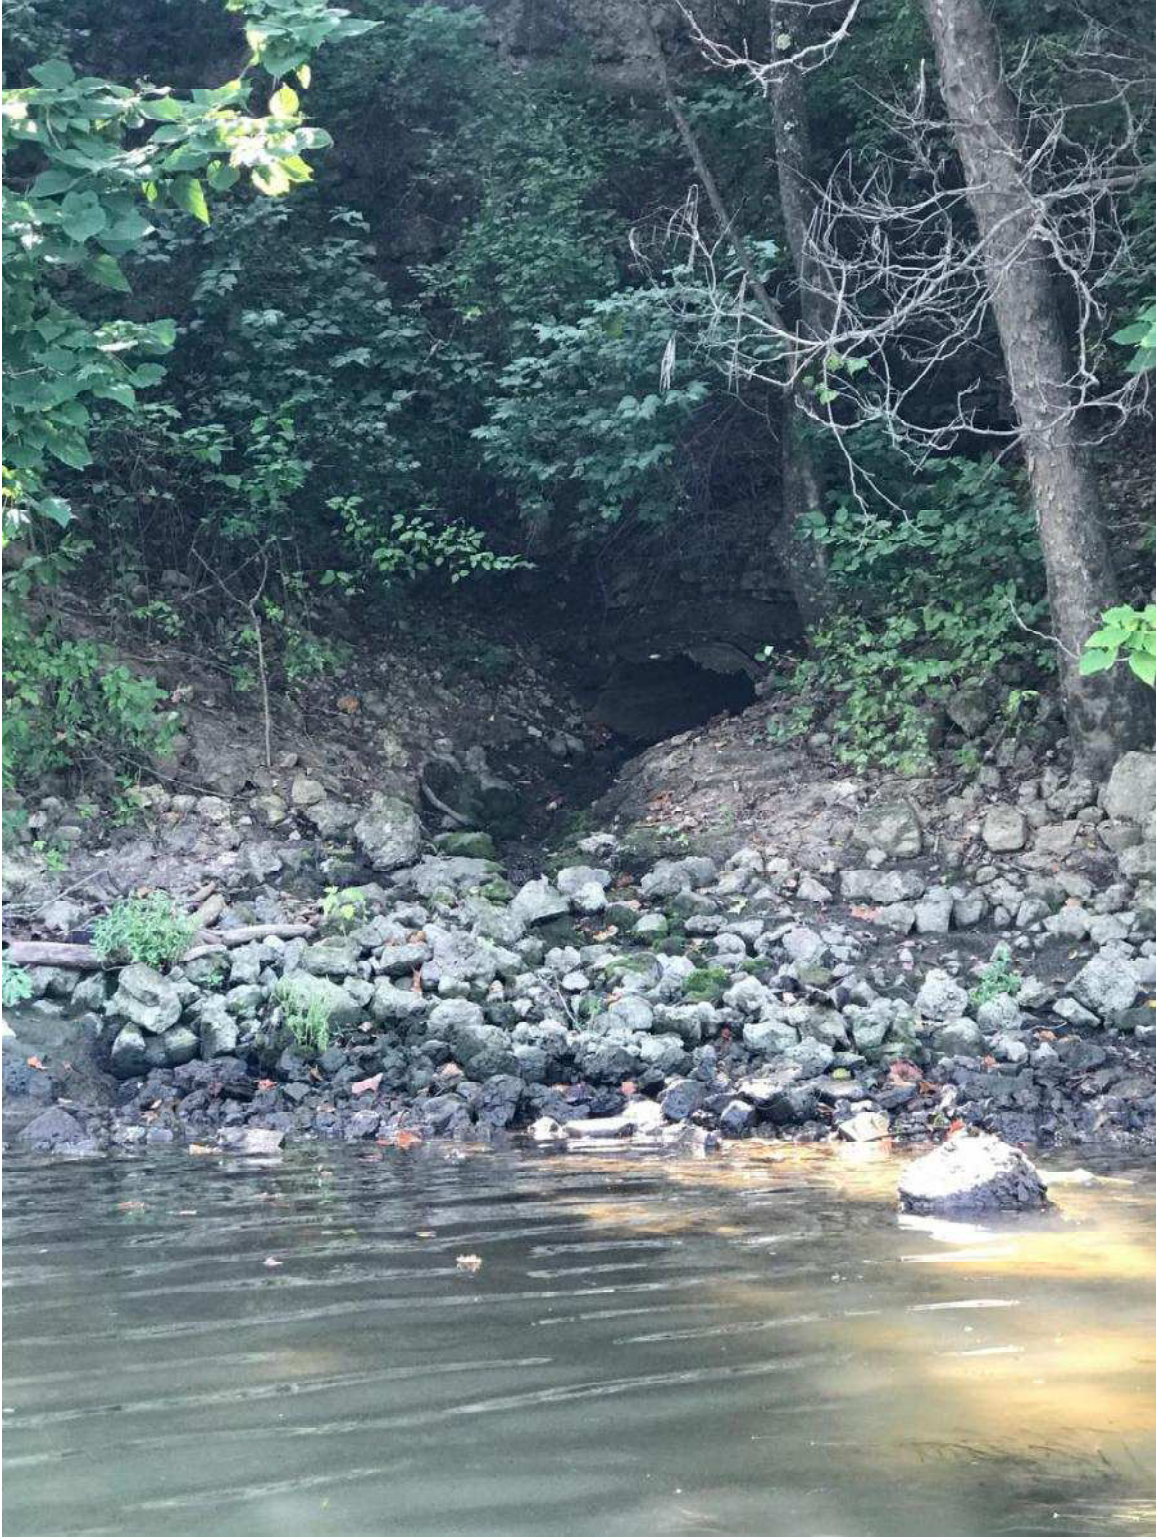
New Outfall A of the Monongahela River.

Inspector Comments:
Outlets to the Monongahela River. Unable to measure the pipe because the screening was performed from a small boat in the river and large barges docked in front of outfall. Outfall partially submerged with sediment. Trickle flow during inspection but flow was clear with no odors. Large area of sediment and debris deposition evident with mild erosion at outfall area. Recommend performing future inspections in the spring prior to heavy foliage and marking the location of the outlet pipe on top of the embankment.

48" Steel pipe

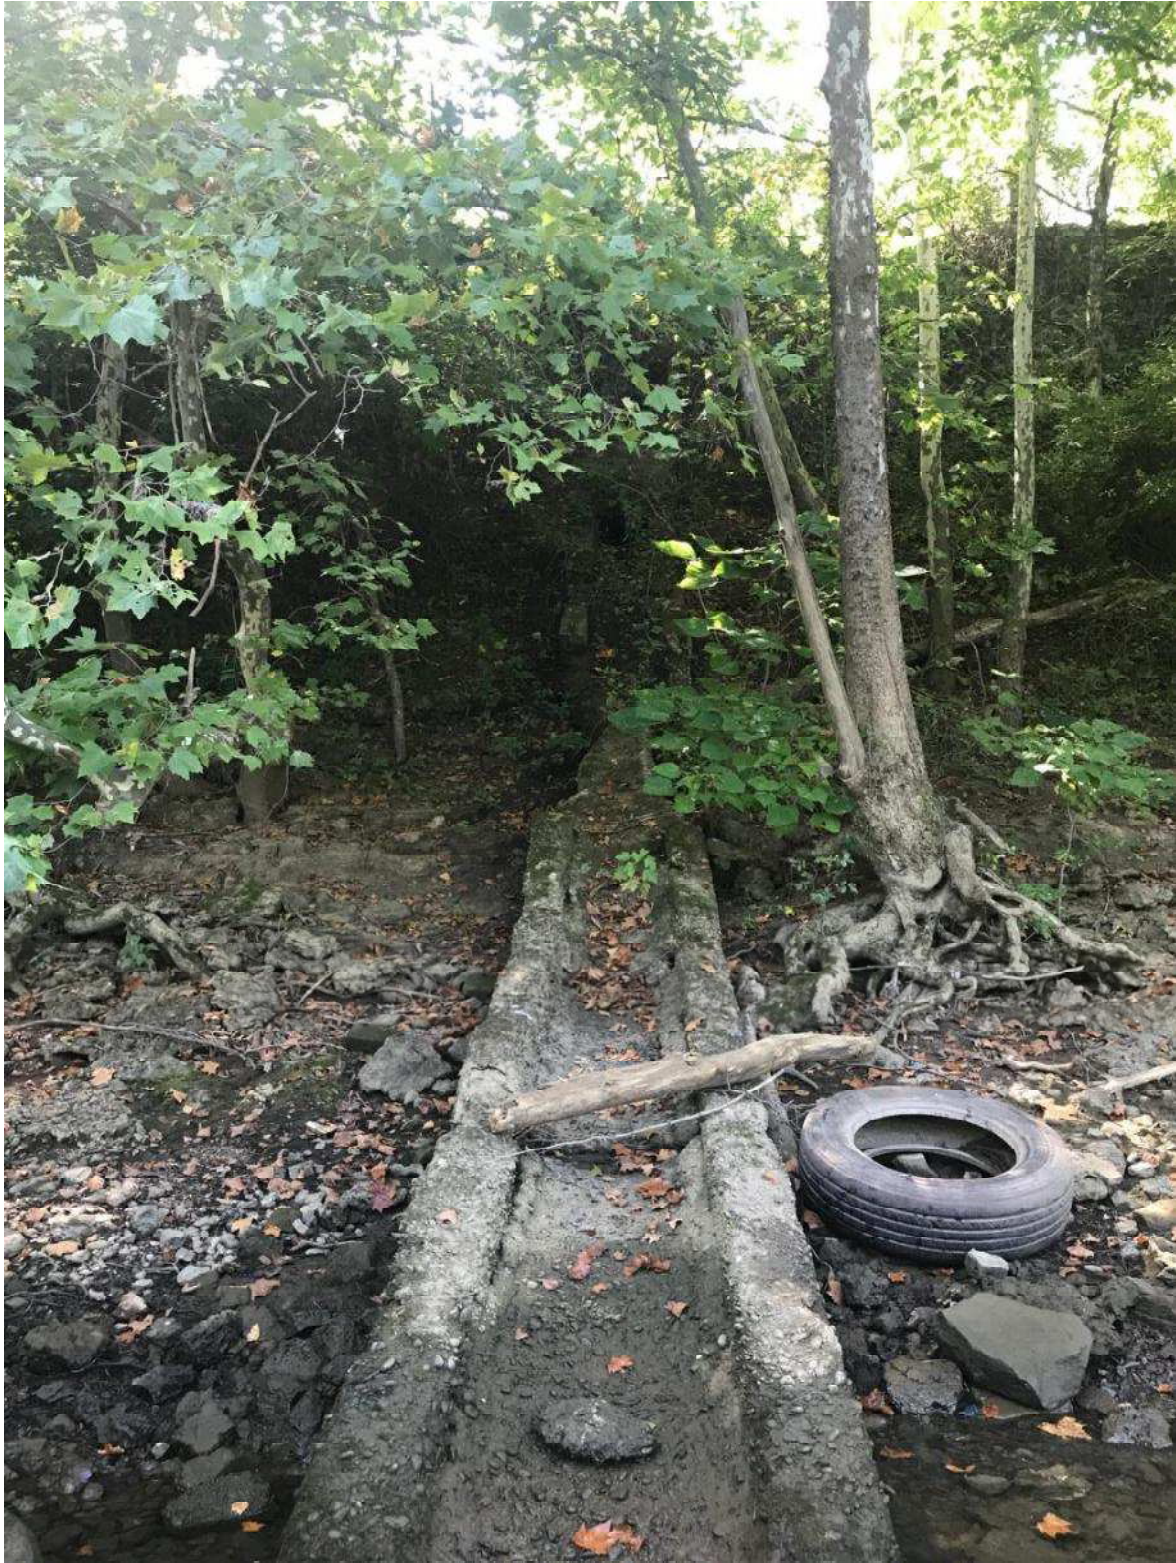
New Outfall B of the Monongahela River. Note existing concrete outlet channel

Outlets to the Monongahela River. The screening was performed from a small boat in the river. Unable to physically measure the pipe. No flow during inspection. Pipe outlets into a long concrete trough extending to river with no erosion evident. Recommend performing next inspection in the spring prior to heavy foliage. Recommend marking the location of the outlet on the top of the embankment.

24" RCP

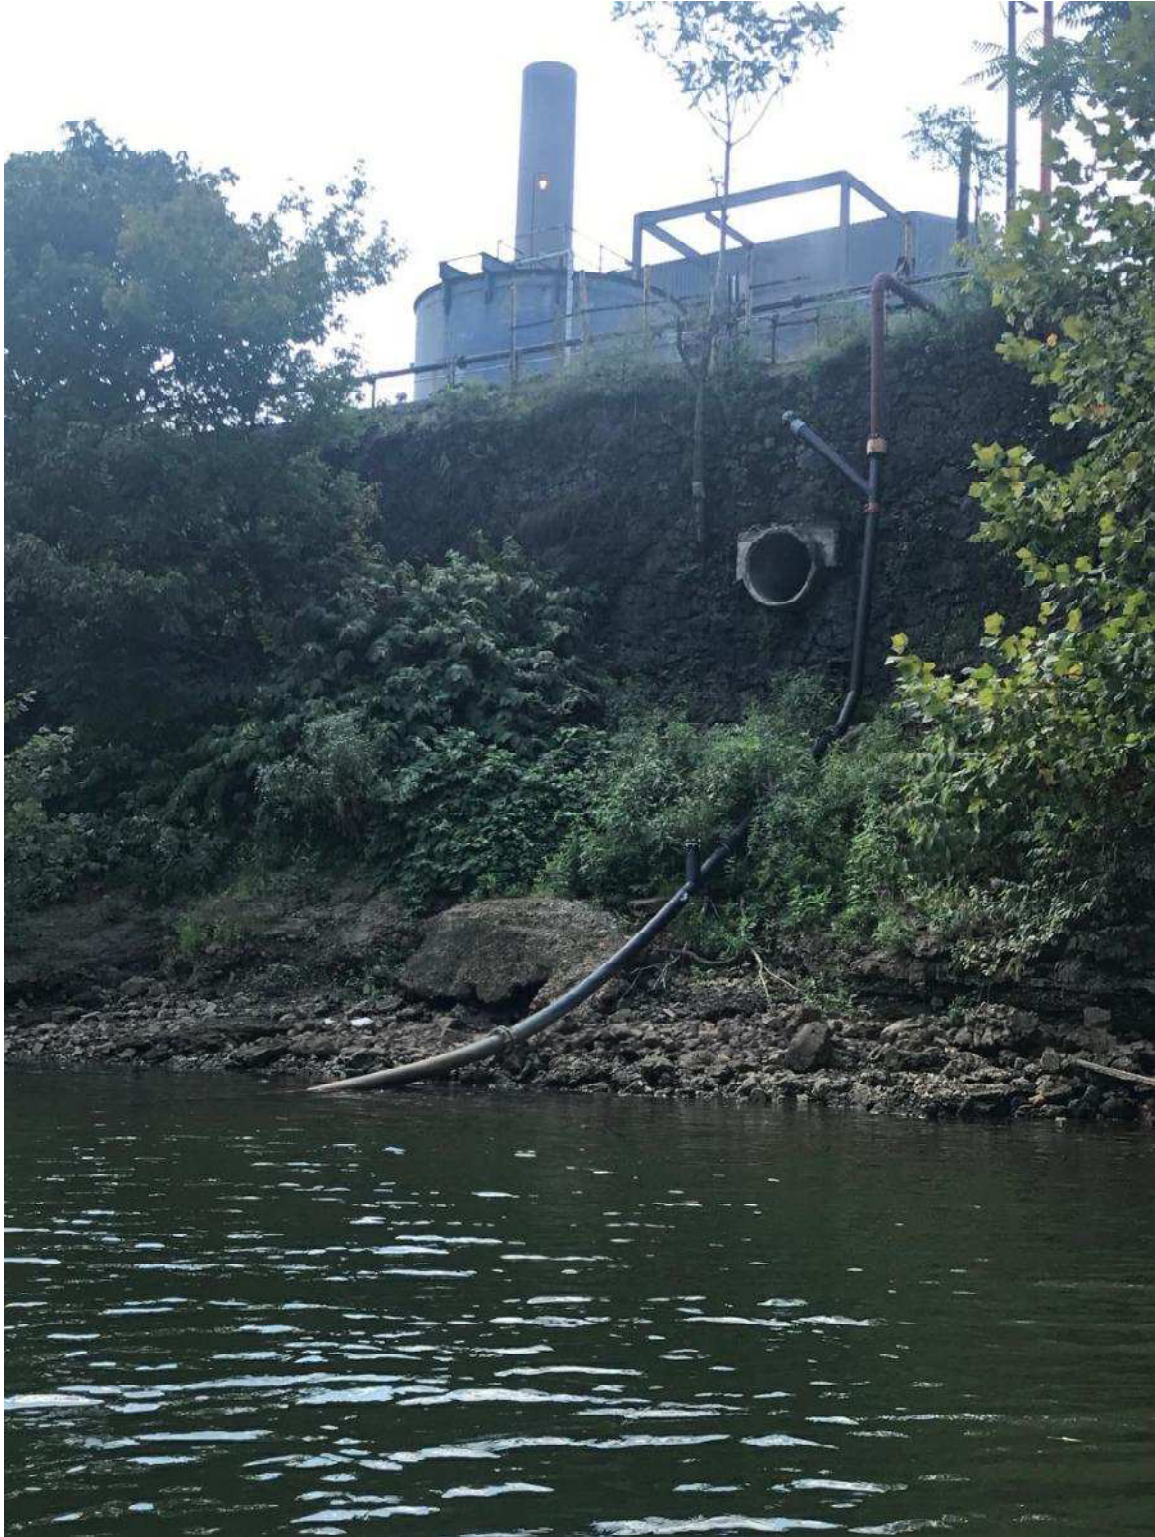
New Outfall C of the Monongahela River. Pipe outlet submerged within river coming from Mill property above. (Potential Illicit Discharge)

8" hose

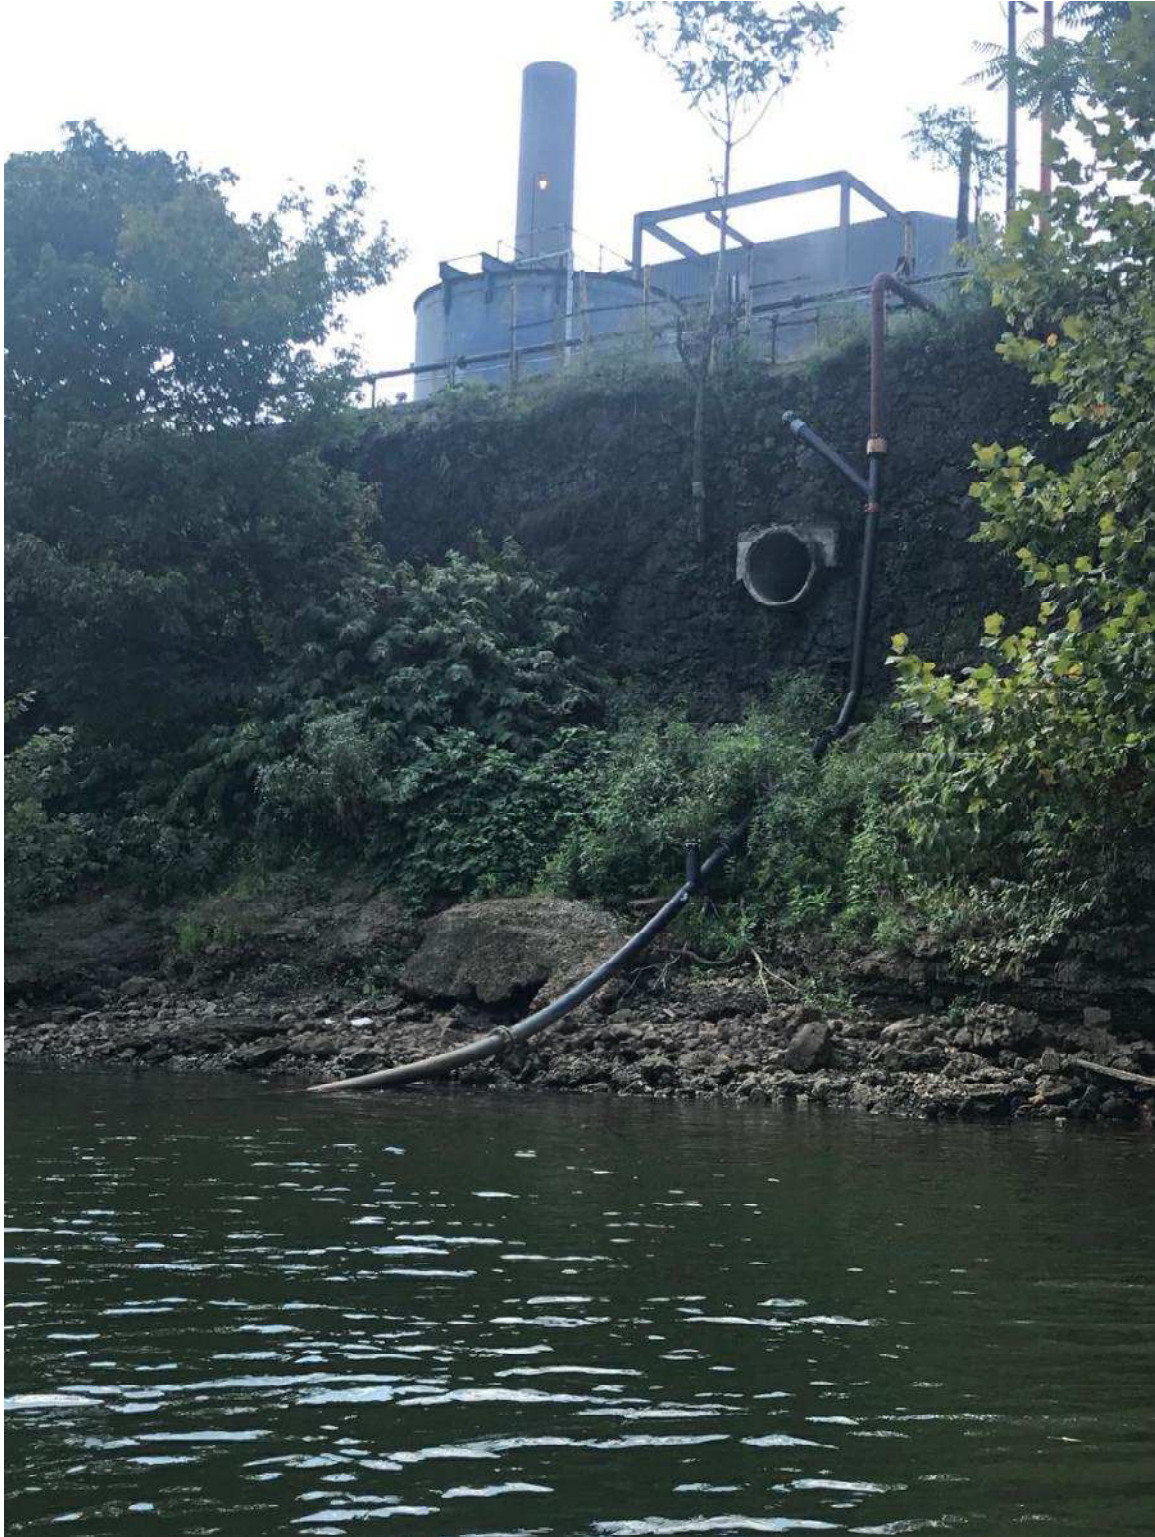
New Outfall D of the Monongahela River. Pipe outlet coming from Mill property above.

30" RCP

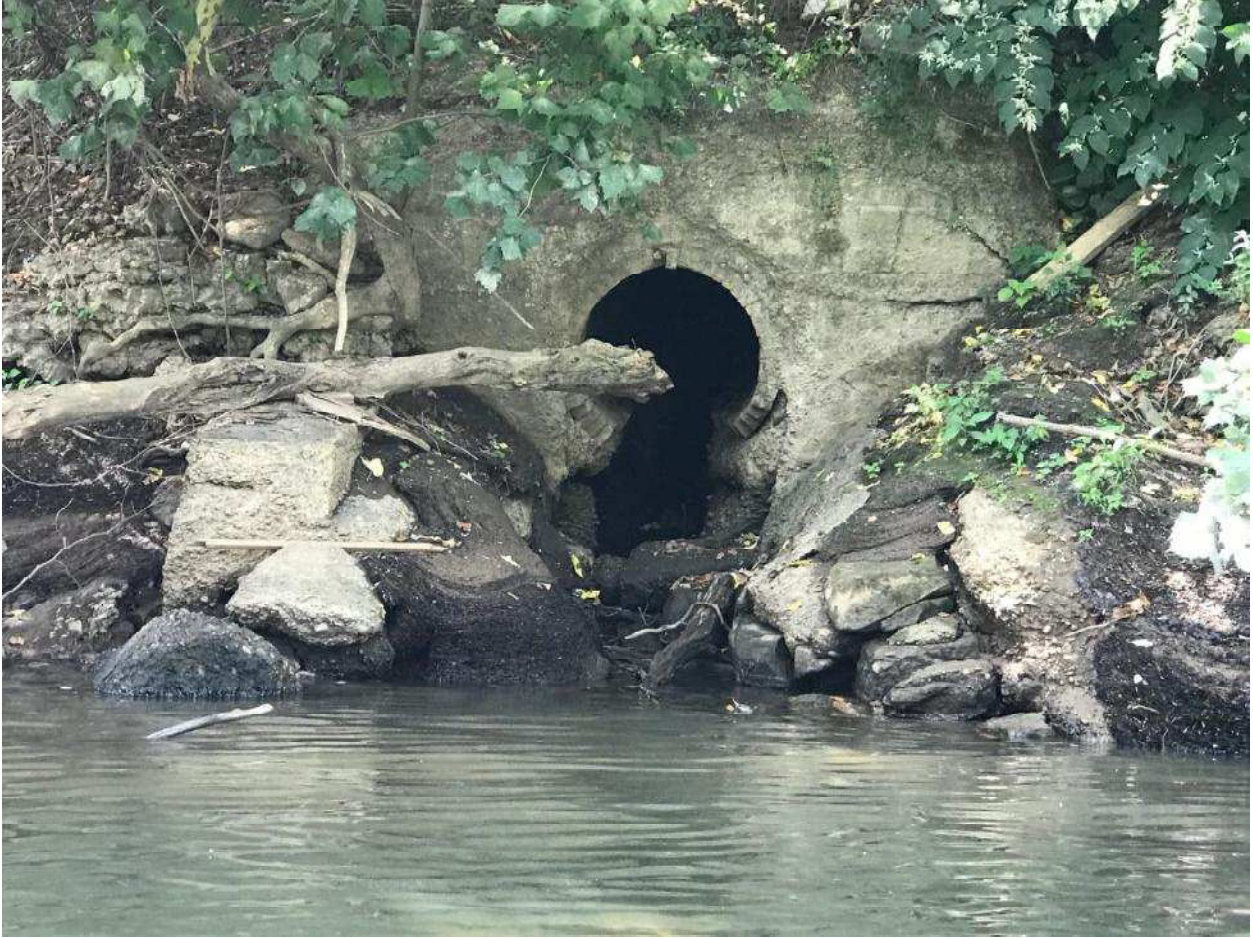
New Outfall E of the Monongahela River. Note invert of pipe eroded away.

30" RCP/Brick

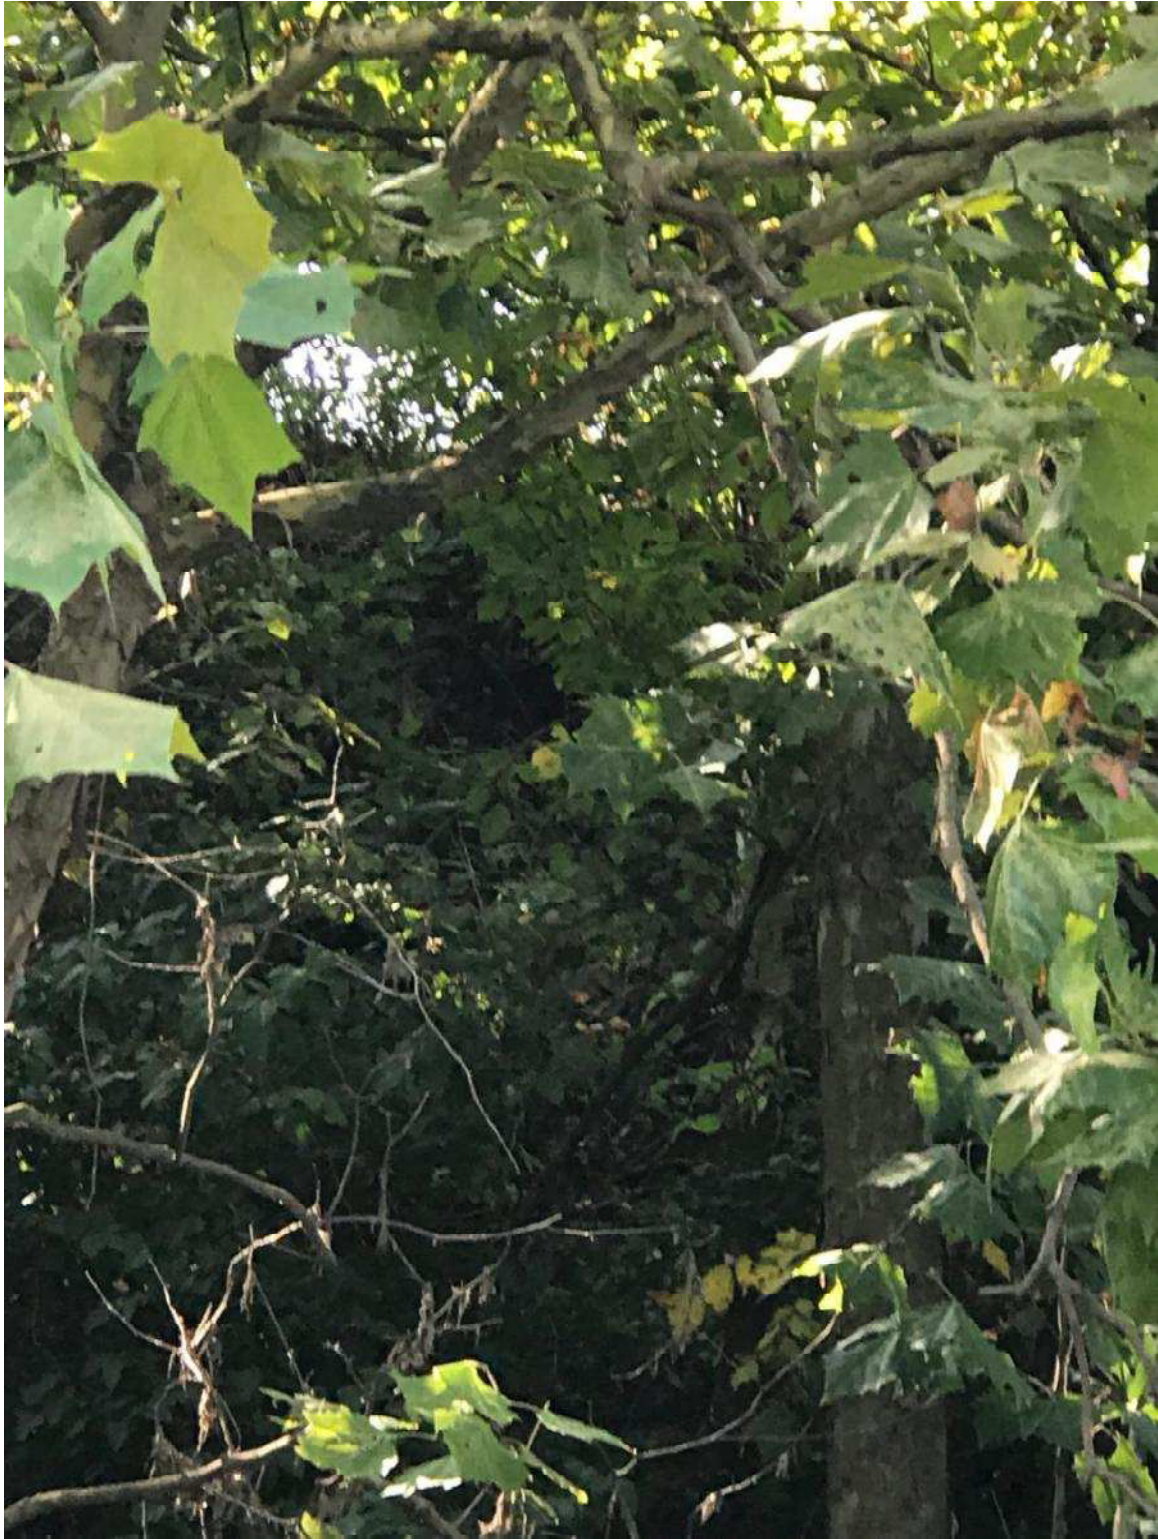
Outfall #SS001 of the Monongahela River. Outfall obscured by heavy vegetation.

Outlets to the Monongahela River. Unable to measure the pipe because the screening was performed from a small boat in the river. No flow during inspection. No erosion at outfall, outlets high on the bank above the river. Recommend performing future inspections in the spring prior to heavy foliage and marking the location of the outlet pipe on top of the embankment.

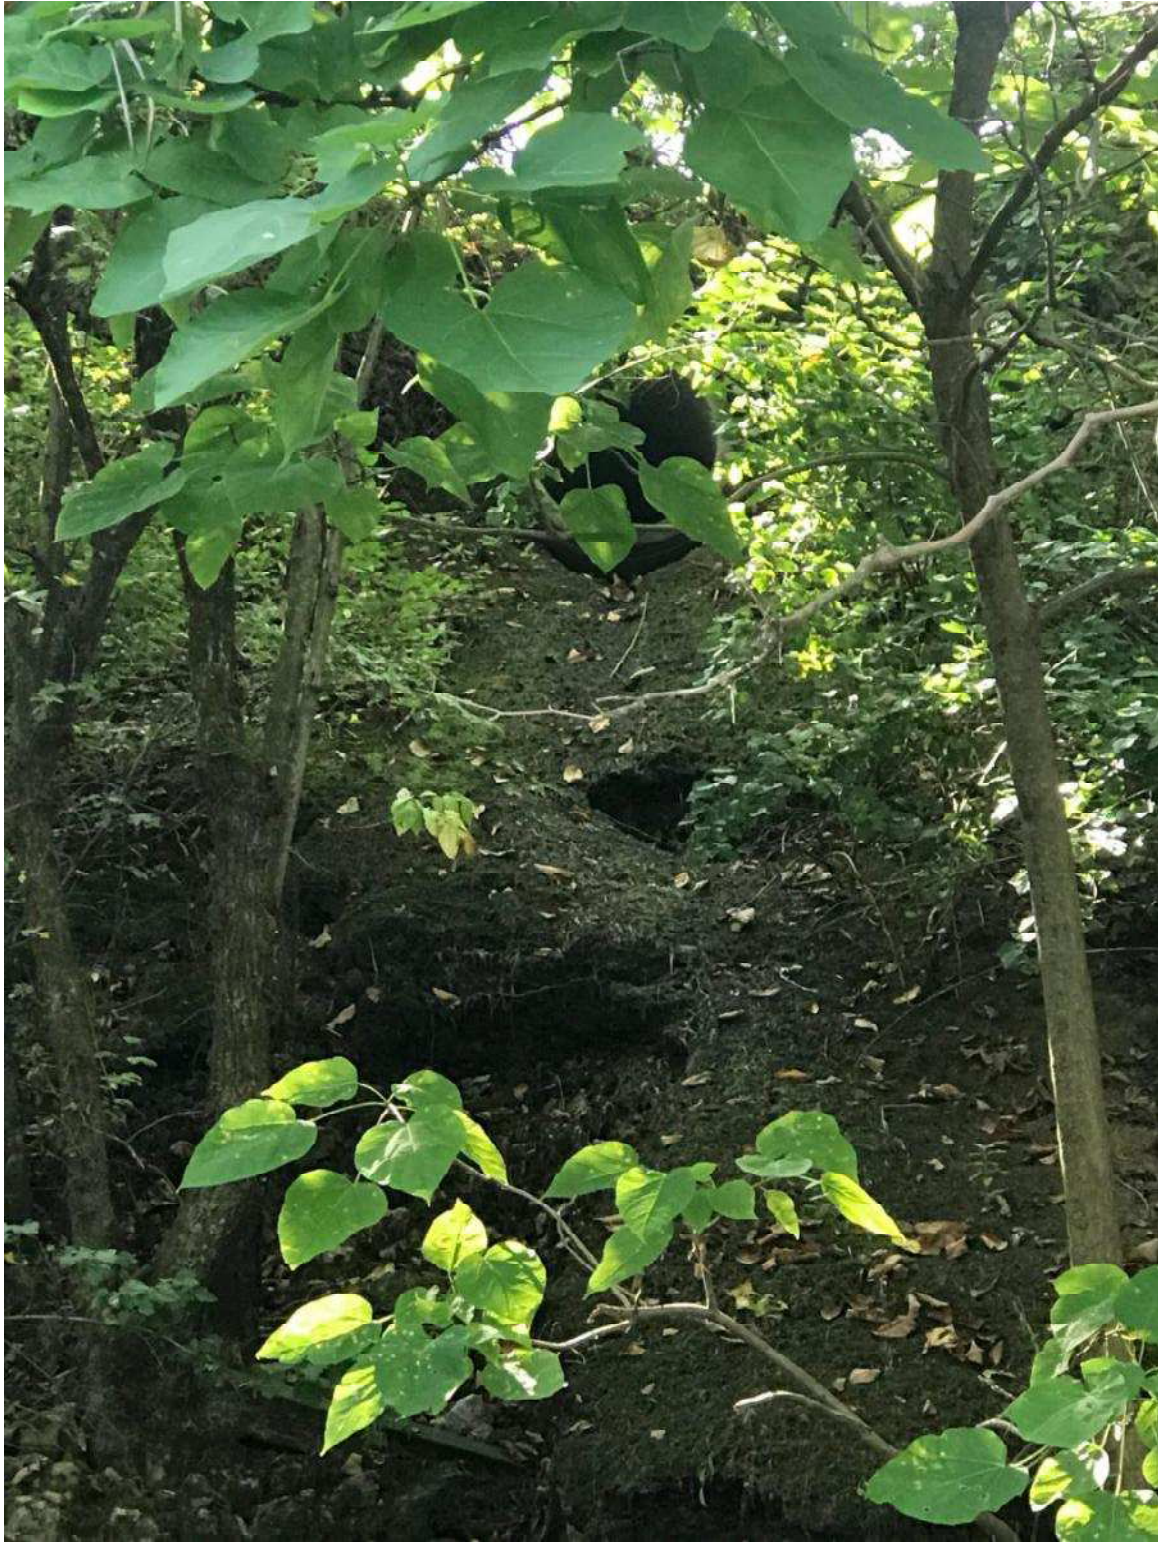
Outfall #SS002 of the Monongahela River. Outfall obscured by heavy vegetation.

Outlets to the Monongahela River. The screening was performed from a small boat in the river. Unable to physically measure the pipe. No flow during inspection. Mild erosion at outfall, but outlets high on the bank above the river. Recommend performing next inspection in the spring prior to heavy foliage. Recommend marking the location of the outlet on the top of the embankment.

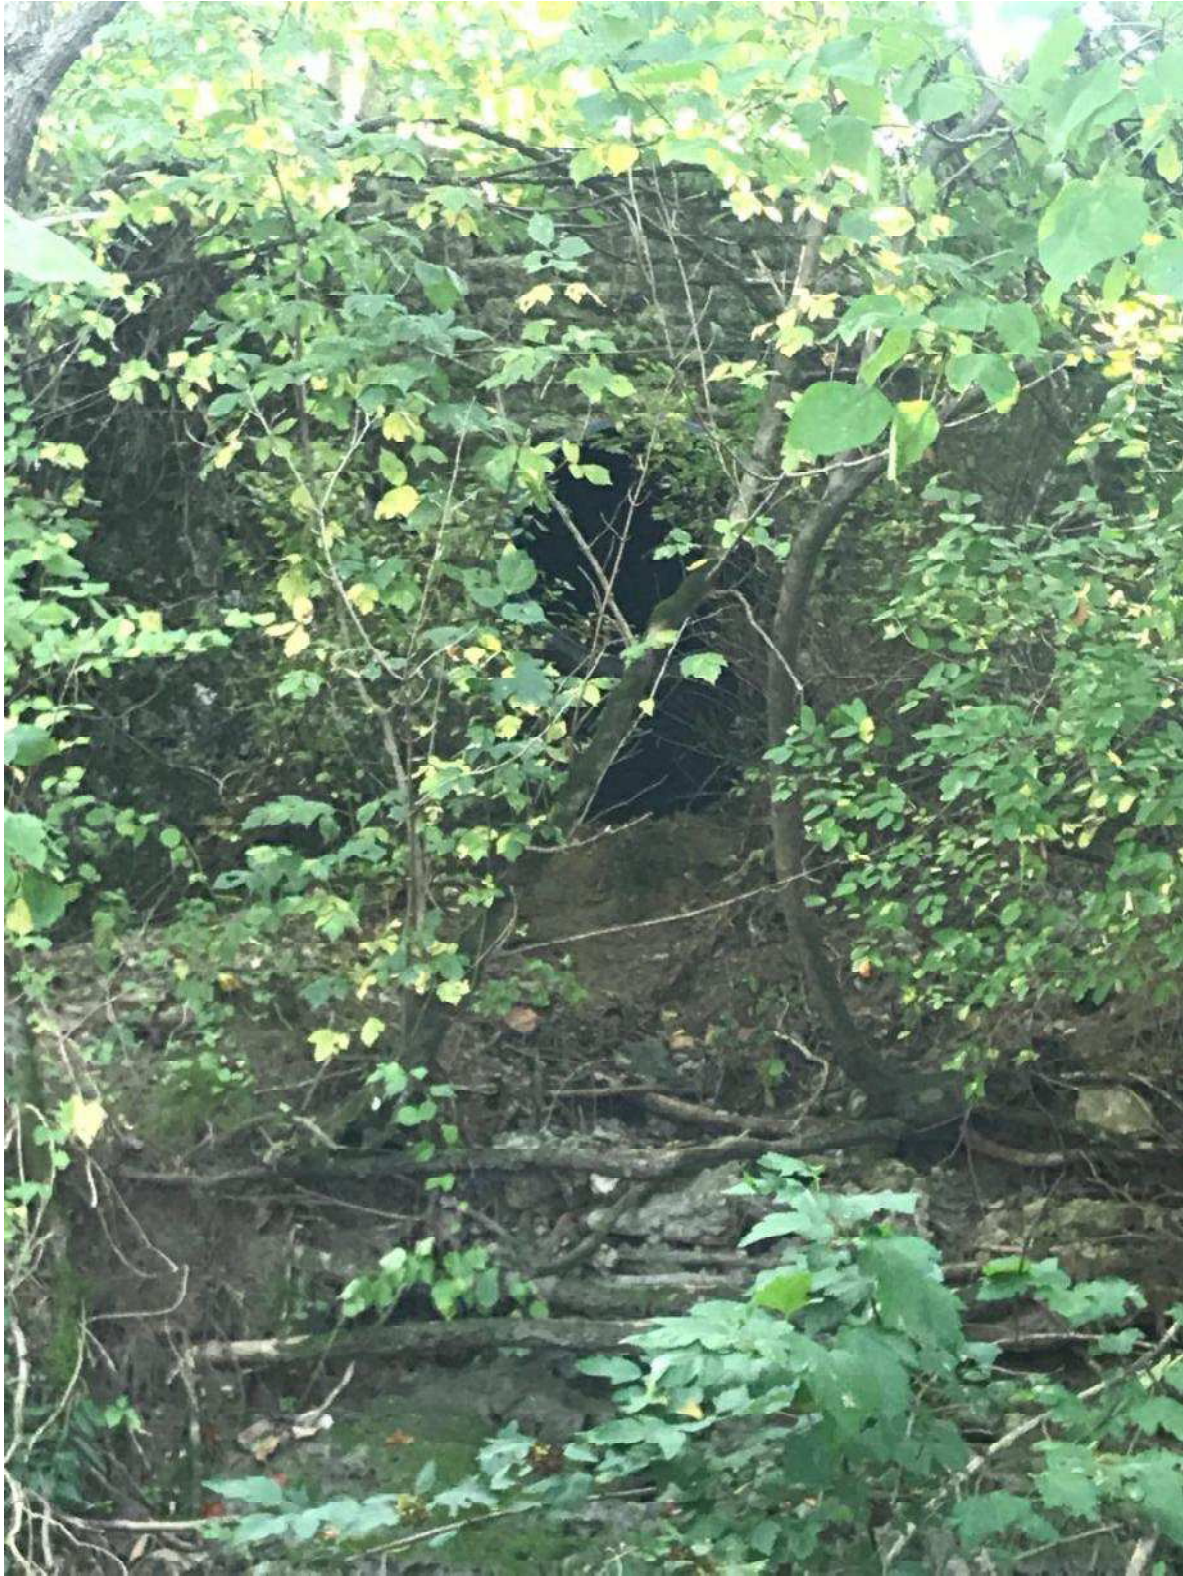
Outfall #SS003 of the Monongahela River. Outfall obscured by heavy vegetation.

Outlets to the Monongahela River. The screening was performed from a small boat in the river. Unable to physically measure the pipe. No flow at the time of inspection. Outfall located high on bank about river with mild erosion evident. Recommend performing next inspection in the spring prior to heavy foliage and marking the approximate location of the outlet on top of the embankment.

36" CPP
