APPENDIX B

Outfall Screening Reports

Monongahela River Outfall Screening Reports

MS4 OUTFALL FIELD SCREENING REPORT

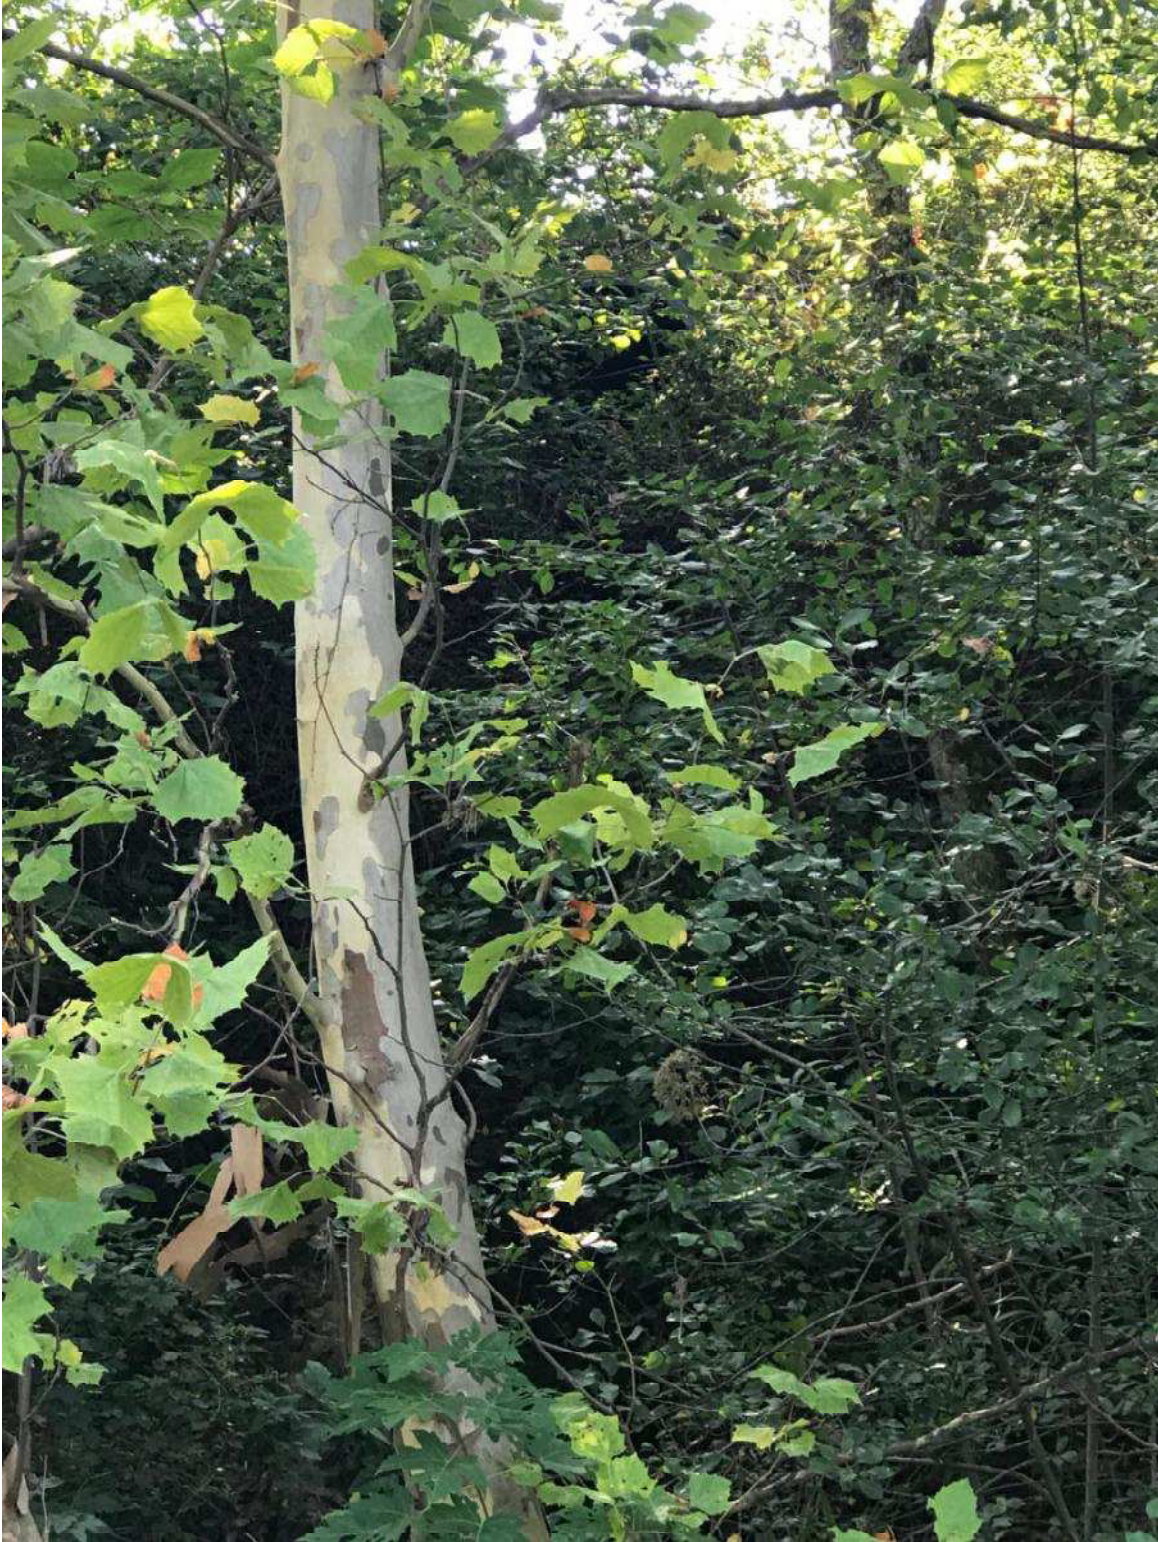
#SS004 of the Monongahela River. Outfall obscured by heavy vegetation.

Outlets to the Monongahela River. The screening was performed from a small boat in the river. Unable to physically measure the pipe. No flow at the time of inspection. Outfall located high on the bank above river with no erosion present. Recommend performing the next inspection in the spring prior to heavy foliage and marking the approximate location of the outlet on the top of the embankment.

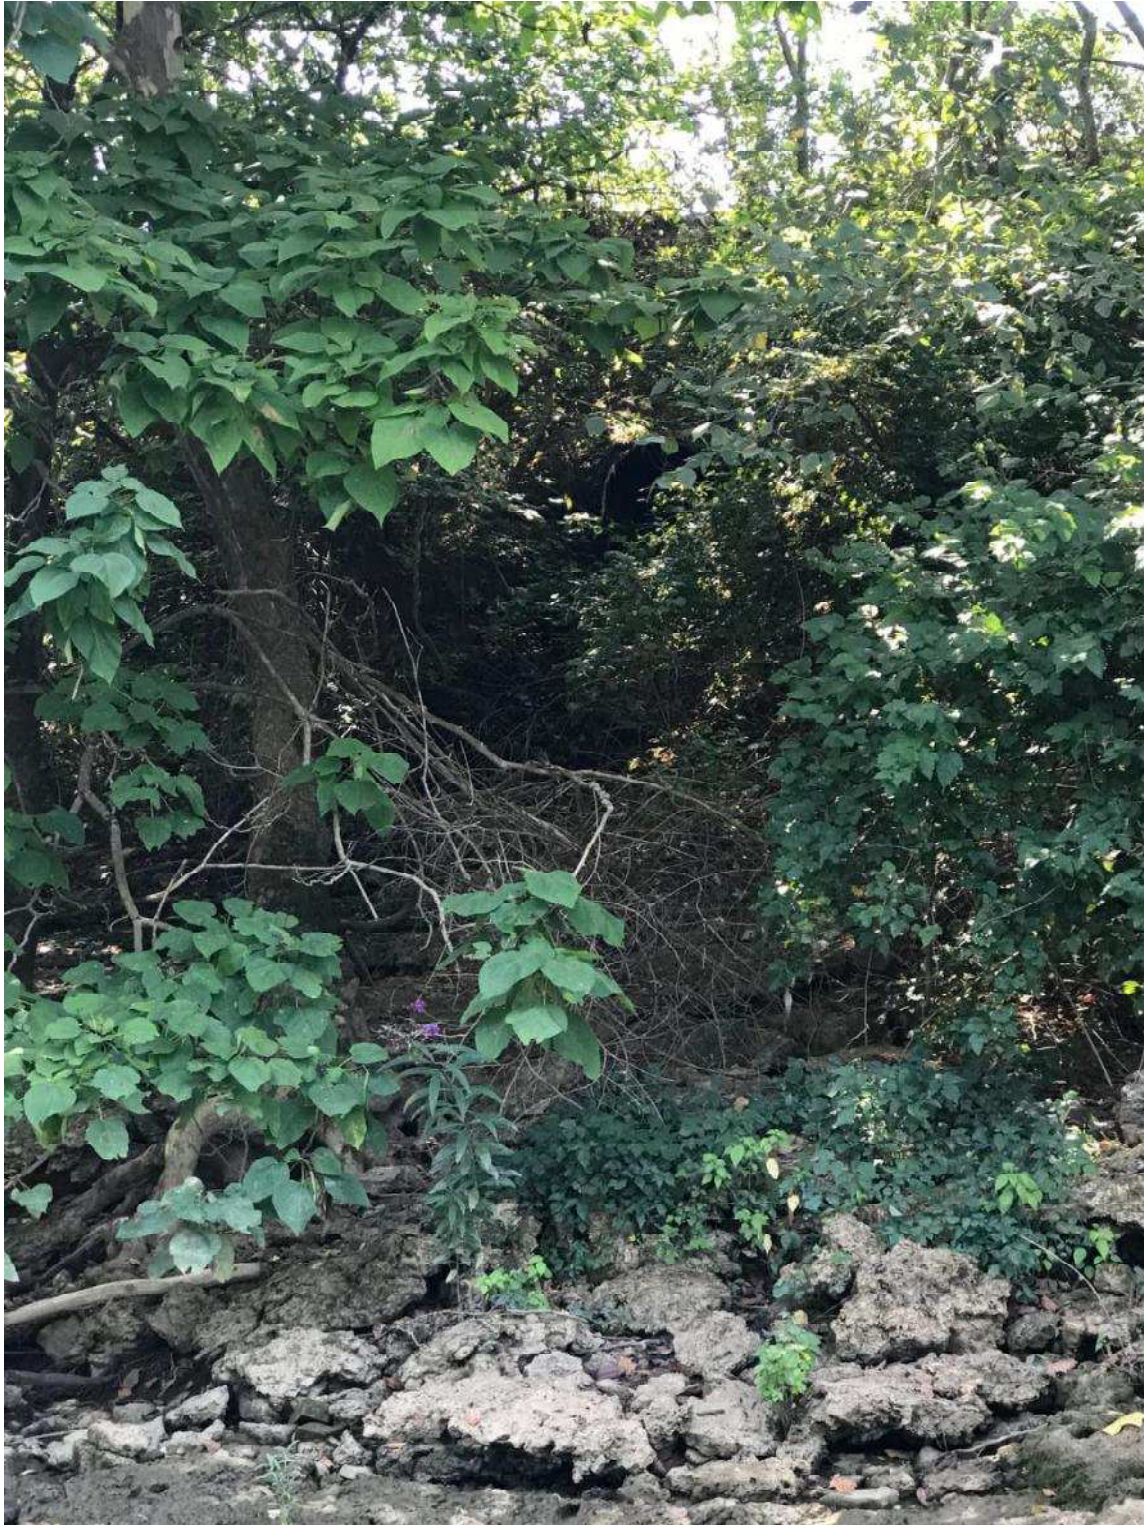
Outfall #SS005 of the Monongahela River. Outfall obscured by heavy vegetation.

Outlets to the Monongahela River. Unable to measure the pipe because the screening was performed from a small boat in the river. No flow at the time of inspection. Outfall located high on bank above the river with moderate erosion evident. Recommend performing the next inspection in the spring prior to heavy foliage and marking the approximate location of the outlet on the top of the embankment.

36" CPP

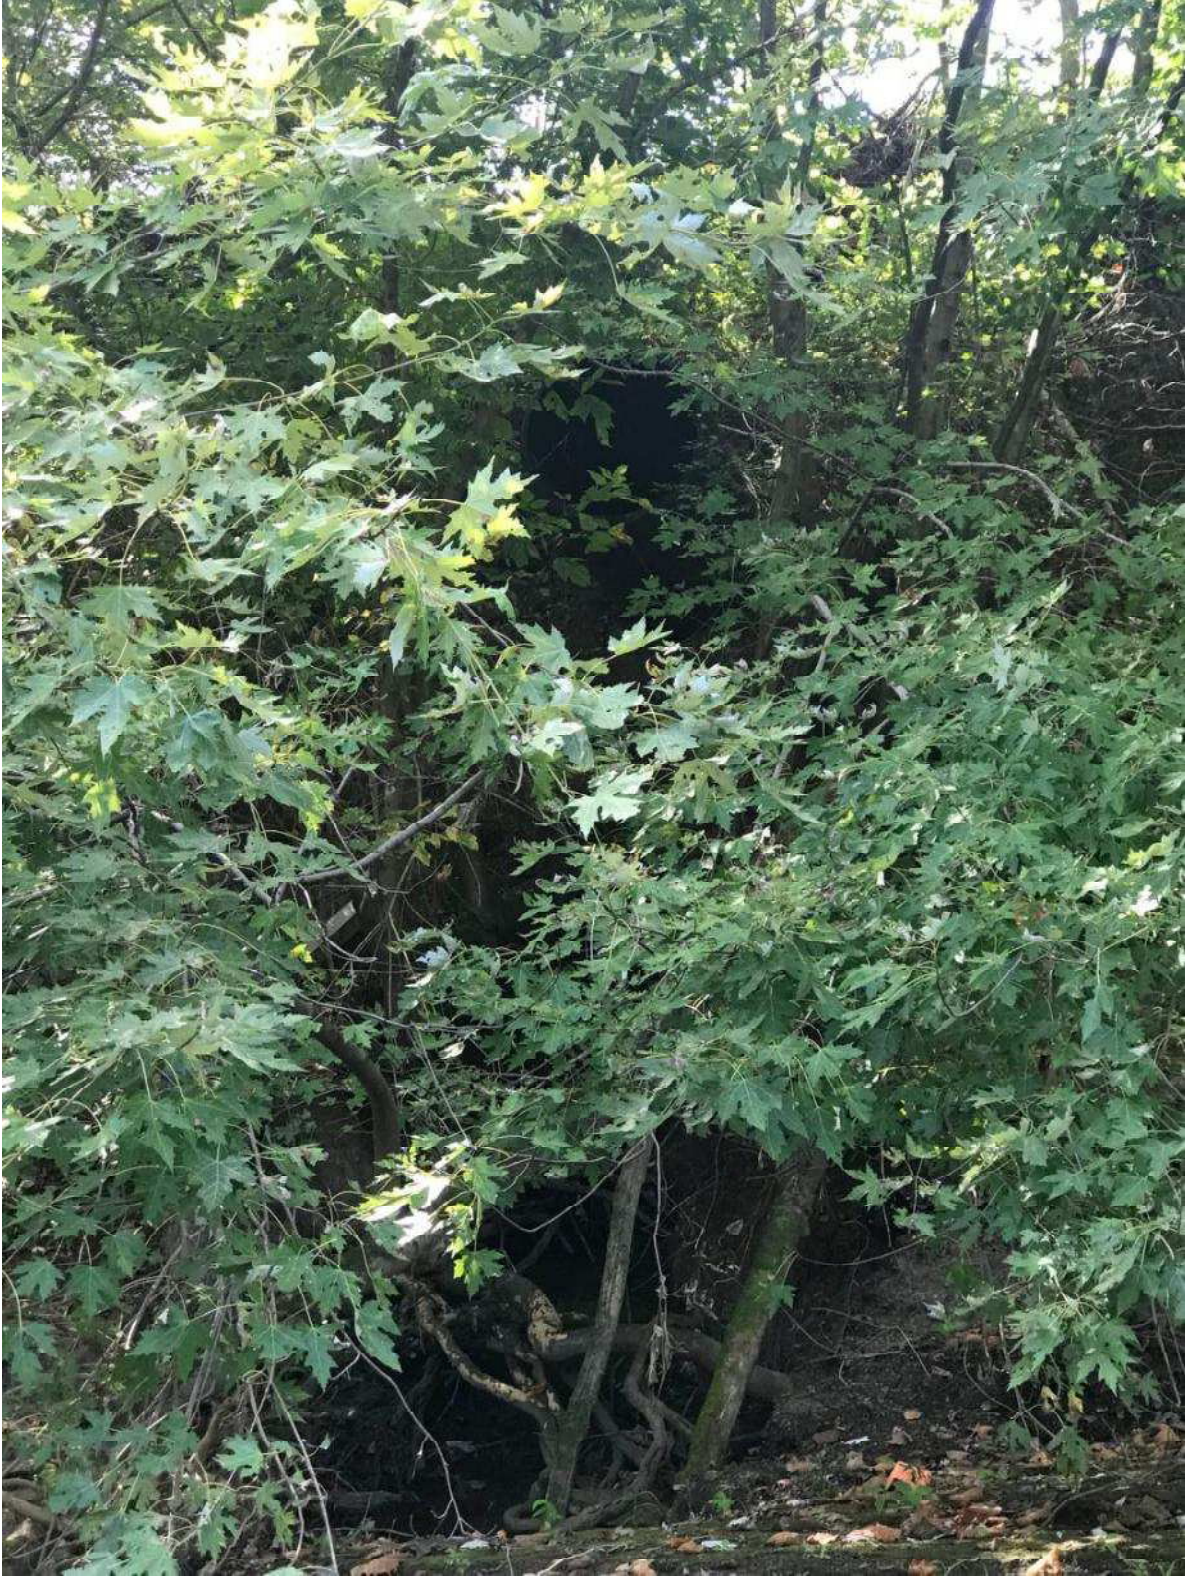
Outfall #SS006 of the Monongahela River. Outfall obscured by heavy vegetation.

Outlets to the Monongahela River. The screening was performed from a small boat in the river. Unable to physically measure the pipe. No dry flow was observed. Outfall located high on the bank above the river with moderate erosion evident. Recommend performing the next inspection in the spring prior to heavy foliage and marking the approximate location of the outlet on the top of the embankment.

36" CPP

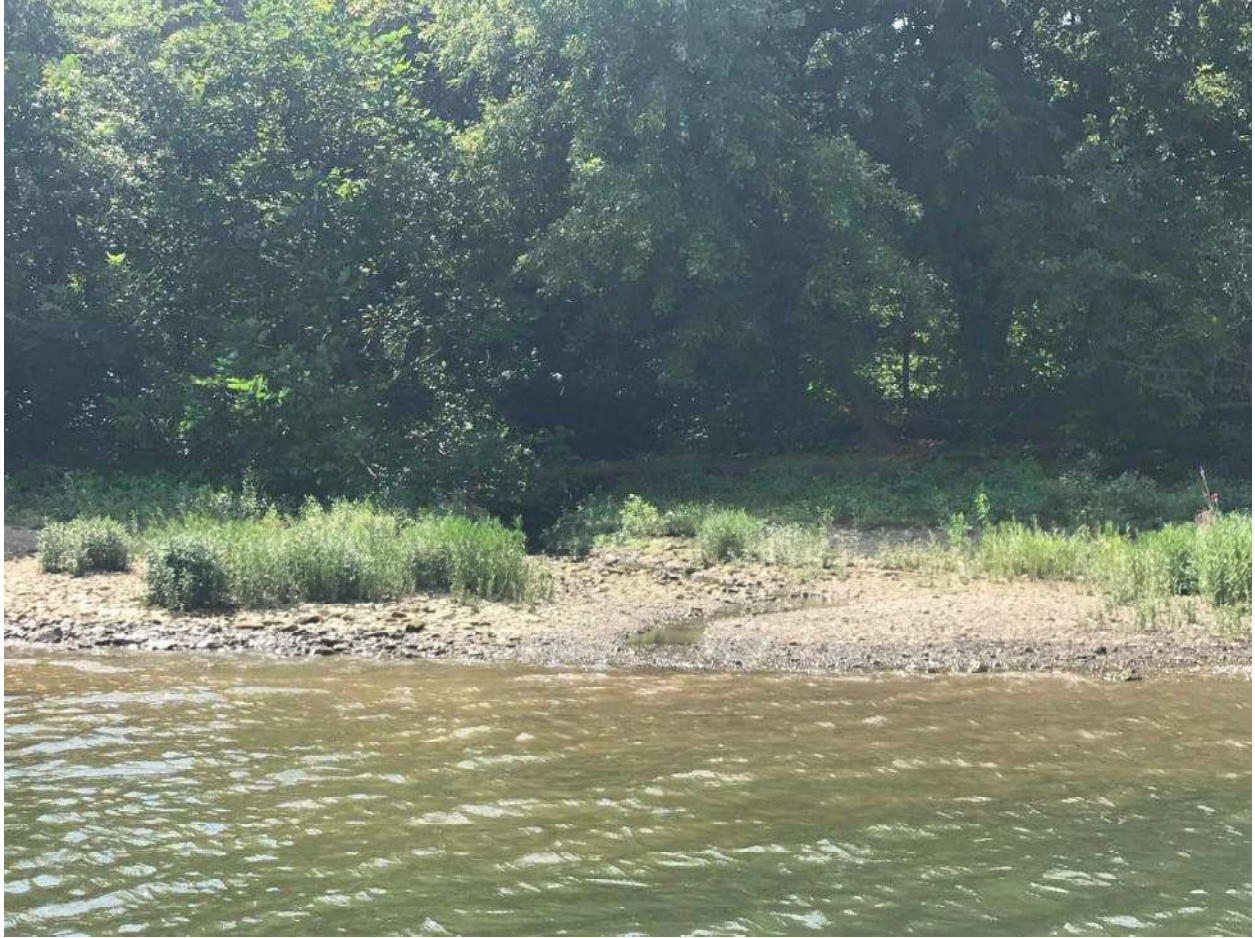
Outfall #SS007 of the Monongahela River. Outfall obscured by heavy vegetation.

36" x 60" box culvert

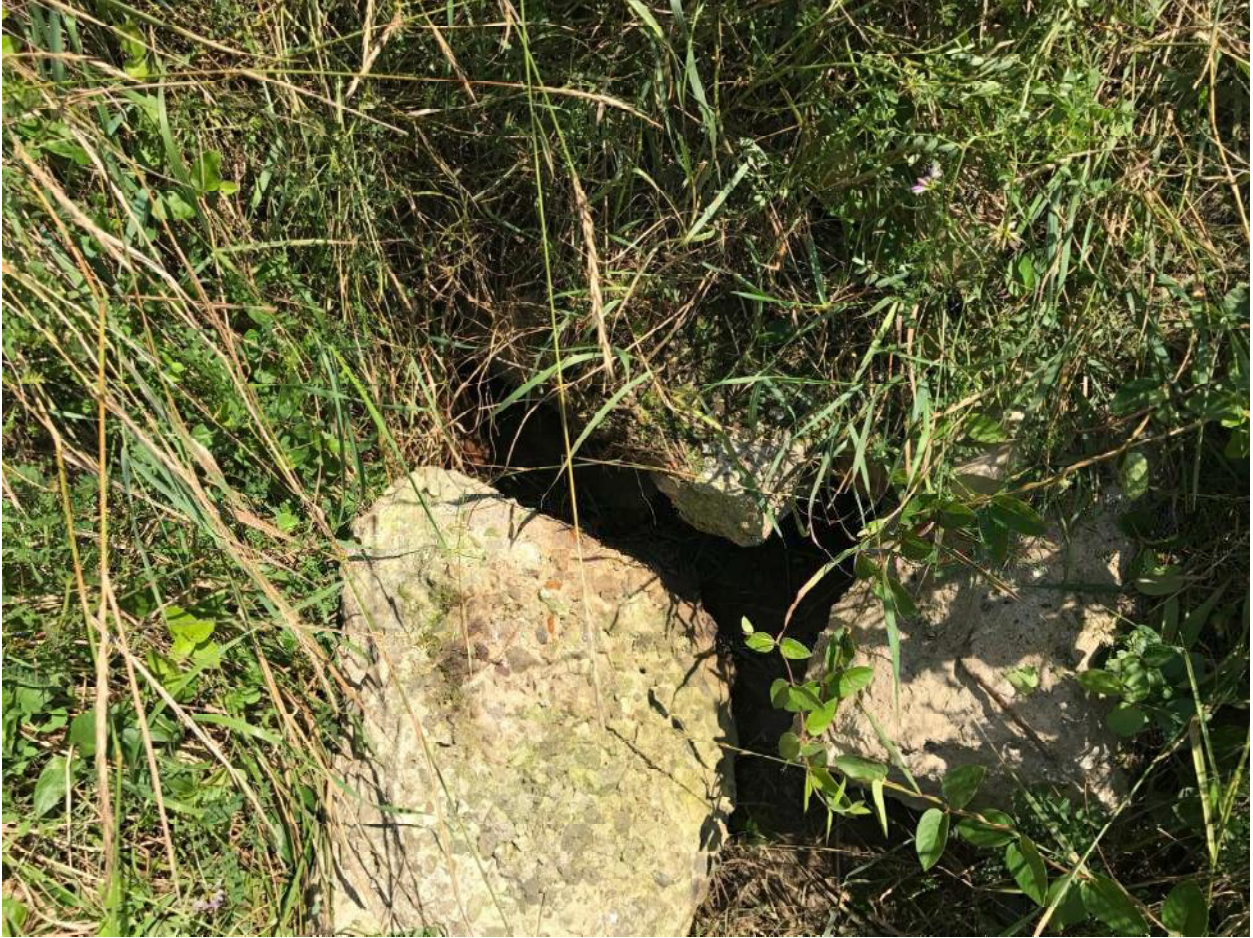
Outfall #2 of UNT #1 to the Monongahela River along Grand Boulevard

Outlets to the UNT #1 to the Monongahela River along Grand Boulevard. No flow during inspection. Pipe is located at the toe of slope in amongst heavy brush and debris and carries stormwater flow from Grand Boulevard and outlets into the stream channel. Pipe outlet was crushed, but visible. Recommend performing future inspections in the spring prior to heavy foliage and marking the location of the outlet pipe with paint or PennDOT approved delineator paddles along UNT#1 channel.

Unknown pipe size and type

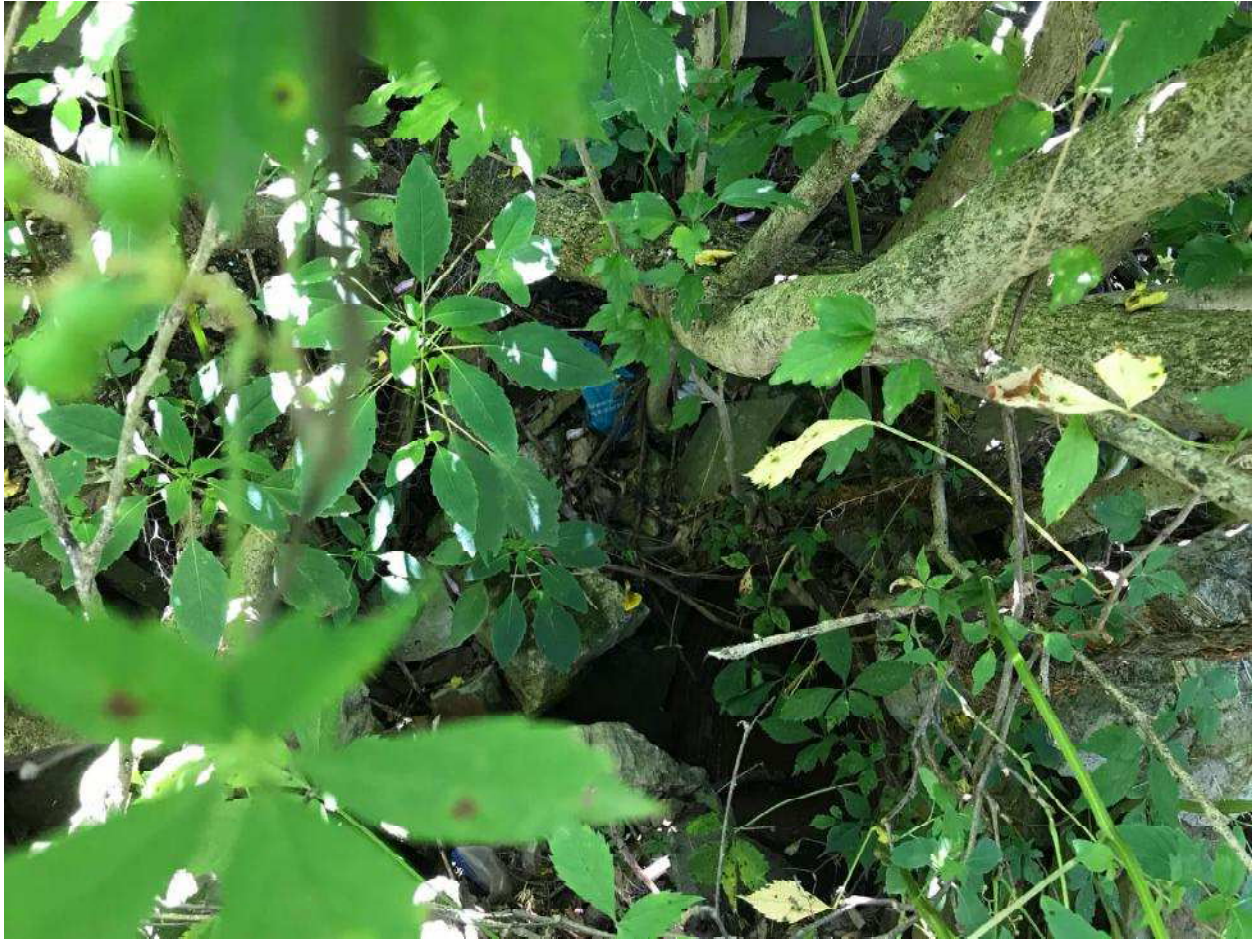
Outfall #3 of UNT #1 to the Monongahela River along Grand Boulevard

Inspector Comments:
Outlets to the UNT #1 to the Monongahela River along Grand Boulevard. No flow during inspection. Pipe is located at the toe of slope in amongst brush and debris and carries stormwater flow from Grand Boulevard and outlets into the stream channel. Recommend performing future inspections in the spring prior to heavy foliage and marking the location of the outlet pipe with paint or PennDOT approved delineator paddles along Grand Boulevard.

18" CPP (outfall obscured by heavy vegetation)

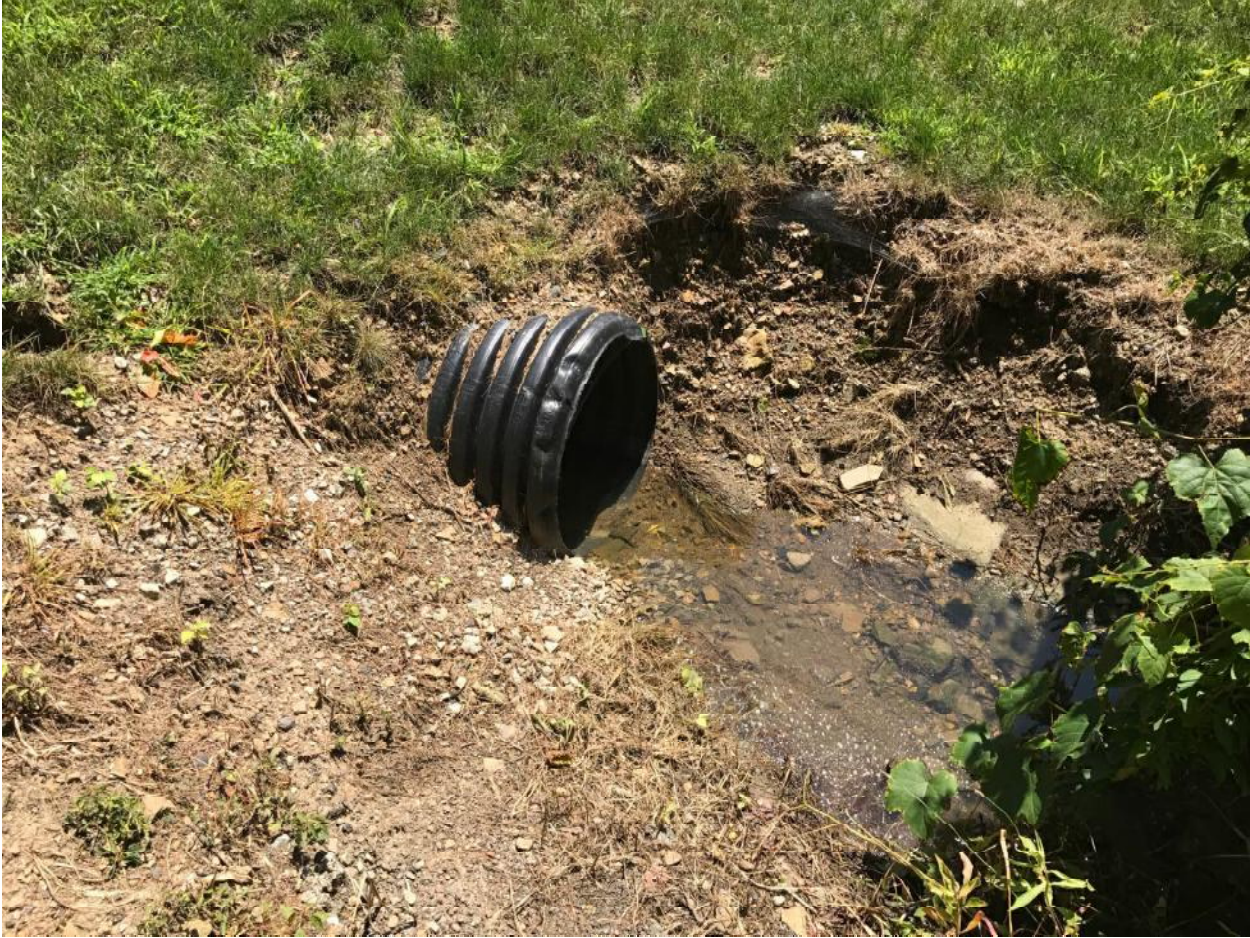
Outfall #4 of UNT #1 to the Monongahela River along Grand Boulevard

Outlets to the UNT #1 to the Monongahela River along Grand Boulevard. End of pipe submerged in standing water, therefore unable to determine flow during inspection. Pipe is located upstream of City Park Road, and carries stormwater/stream flow under a residence and outlets into the stream channel. Recommend performing future inspections in the spring prior to heavy foliage and marking the location of the outlet pipe with paint or PennDOT approved delineator paddles along UNT#1 channel.

18" CPP
