MS4 OUTFALL FIELD SCREENING REPORT

Permittee Name: City of Monessen	NPDES Permit No.: PAG136283
Date of Inspection: June 26, 2018	Outfall ID No.: 005
Land Uses in Outfall Drainage Area (Select All): <input type="checkbox"/> Industrial <input type="checkbox"/> Urban Residential <input type="checkbox"/> Commercial <input checked="" type="checkbox"/> Suburban Residential <input type="checkbox"/> Open Space <input type="checkbox"/> Other:	Latitude: 40° 08' 40.26"
	Longitude: 79° 52' 19.34"
	Dry Weather Inspection? <input checked="" type="checkbox"/> Yes <input type="checkbox"/> No
	Date of Previous Precipitation: 6/22/18
	Amount of Previous Precipitation: 0.66 in
Inspector Name(s): John M. Casagranda and Adam D. Polachek	Were Photographs Taken? <input checked="" type="checkbox"/> Yes <input type="checkbox"/> No
	Are Photographs Attached? <input checked="" type="checkbox"/> Yes <input type="checkbox"/> No

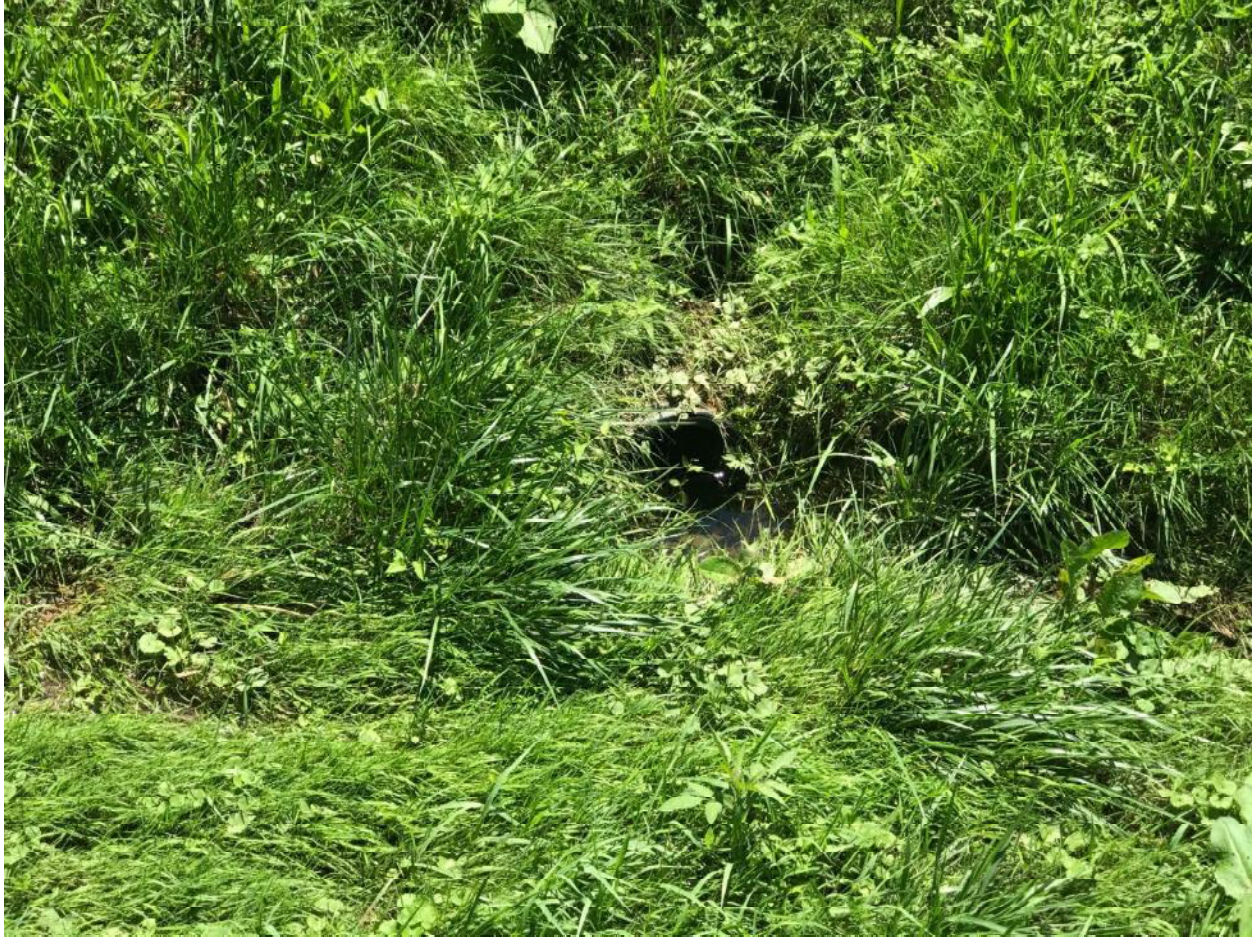
Outfall #5 of UNT #1 to the Monongahela River along Grand Boulevard

Outlets to the UNT #1 to the Monongahela River along Grand Boulevard. End of pipe submerged in standing water, therefore unable to determine flow during inspection. Pipe is located along stream channel upstream of City Park Road, and carries residential stormwater from downspouts into the stream channel. Recommend performing future inspections in the spring prior to heavy foliage and marking the location of the outlet pipe with paint or PennDOT approved delineator paddles along UNT#1 channel.

6" CPP

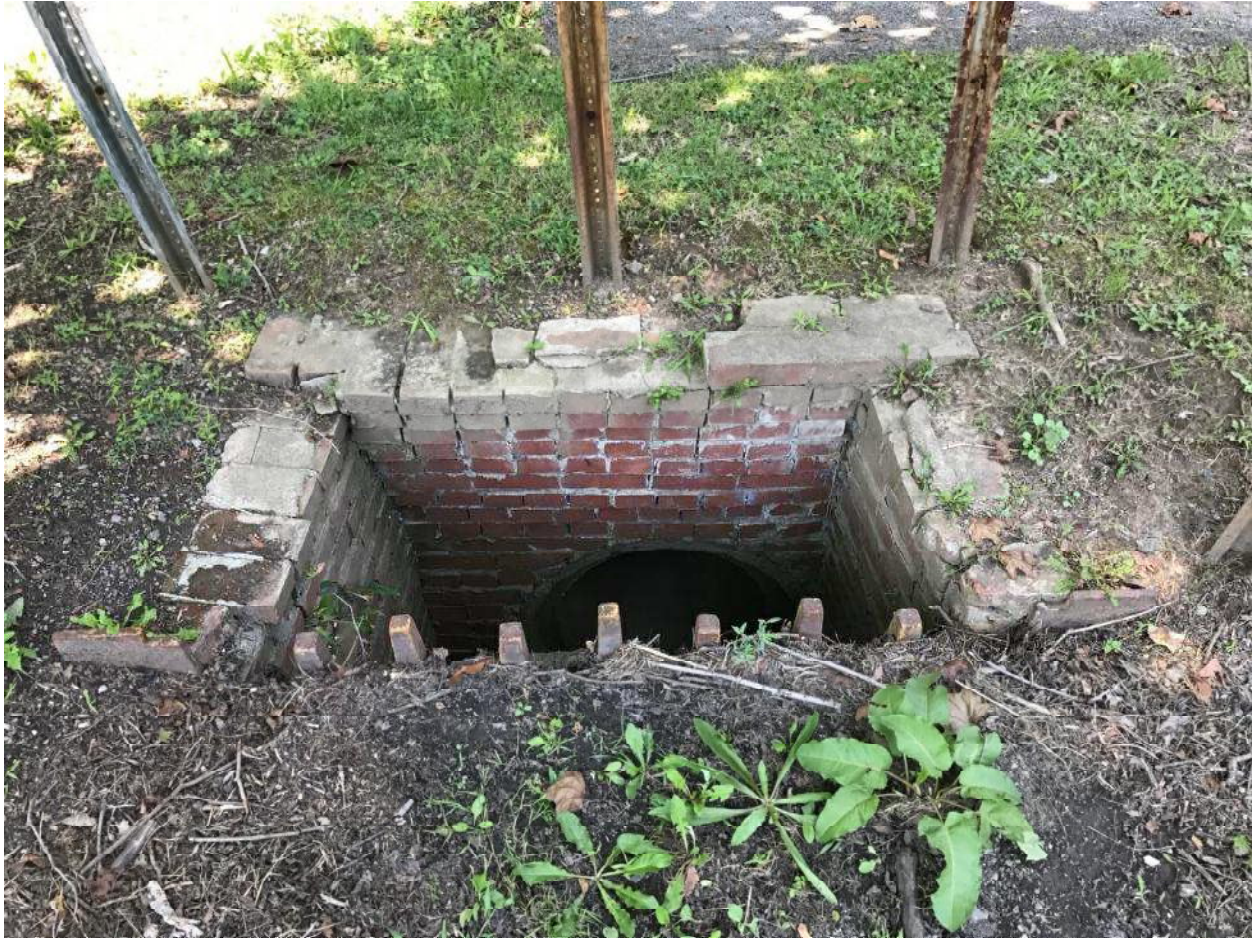
Outfall #6 of UNT #1 to the Monongahela River along Grand Boulevard

Outlets to the UNT #1 to the Monongahela River along Grand Boulevard. No flow during inspection. Inlet is located along City Park Road, and carries stormwater from City Park Road and outlets directly into the culvert carrying the stream channel under City Park Road. Recommend removing sediment located in bottom of inlet during regular maintenance activities.

2' x 4' brick inlet box

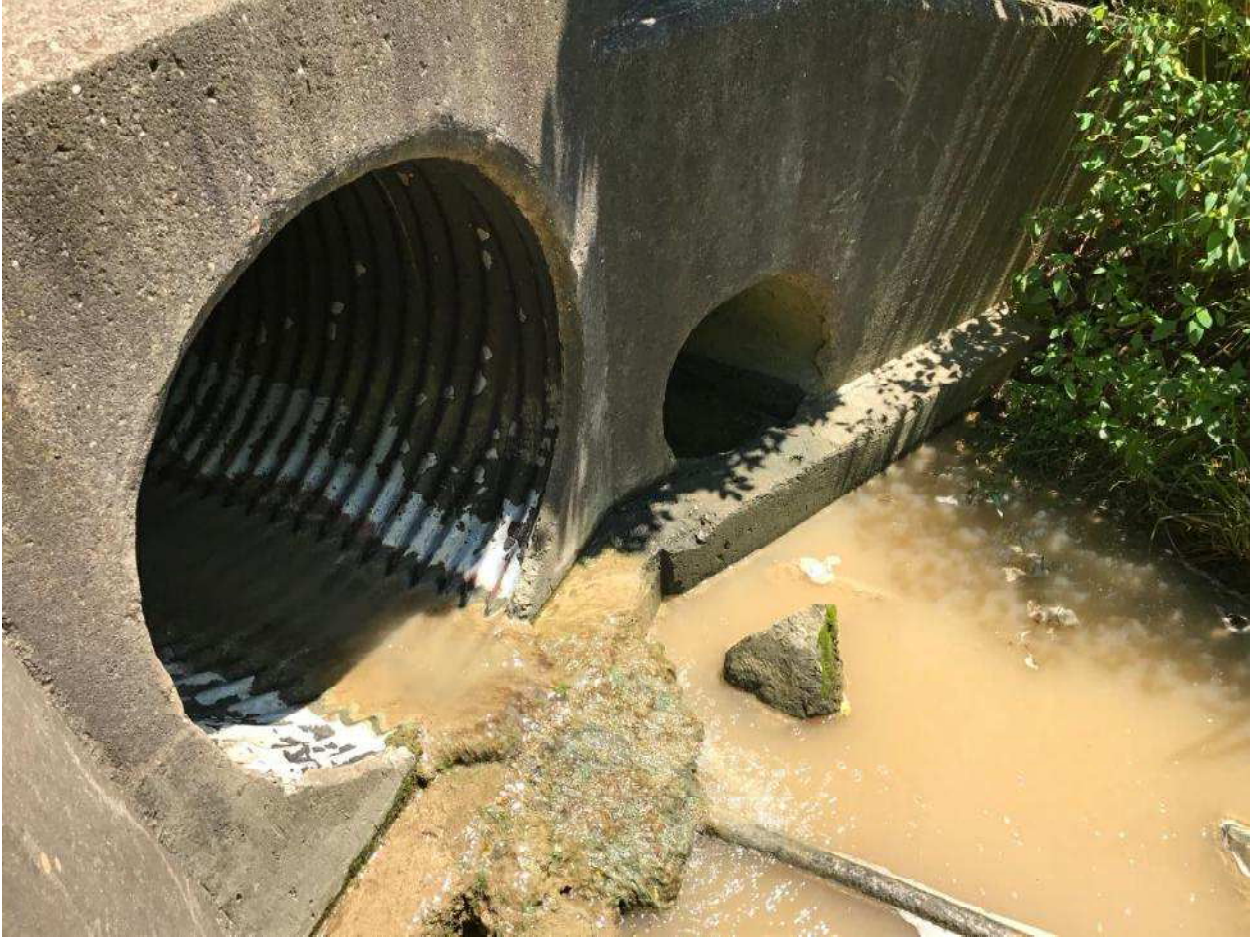
Outfall #7 of UNT #1 to the Monongahela River along Grand Boulevard

Outlets to the UNT #1 to the Monongahela River along Grand Boulevard. Moderate flow during inspection. Pipe is located under City Park parking lot, and carries stormwater from City Park Road and outlets into the stream channel. A steady flow present because pipe picks up numerous springs from drainage area. Recommend performing future inspections in the spring prior to heavy foliage and marking the location of the outlet pipe with paint or PennDOT approved delineator paddles along Grand Boulevard.

45" CMP

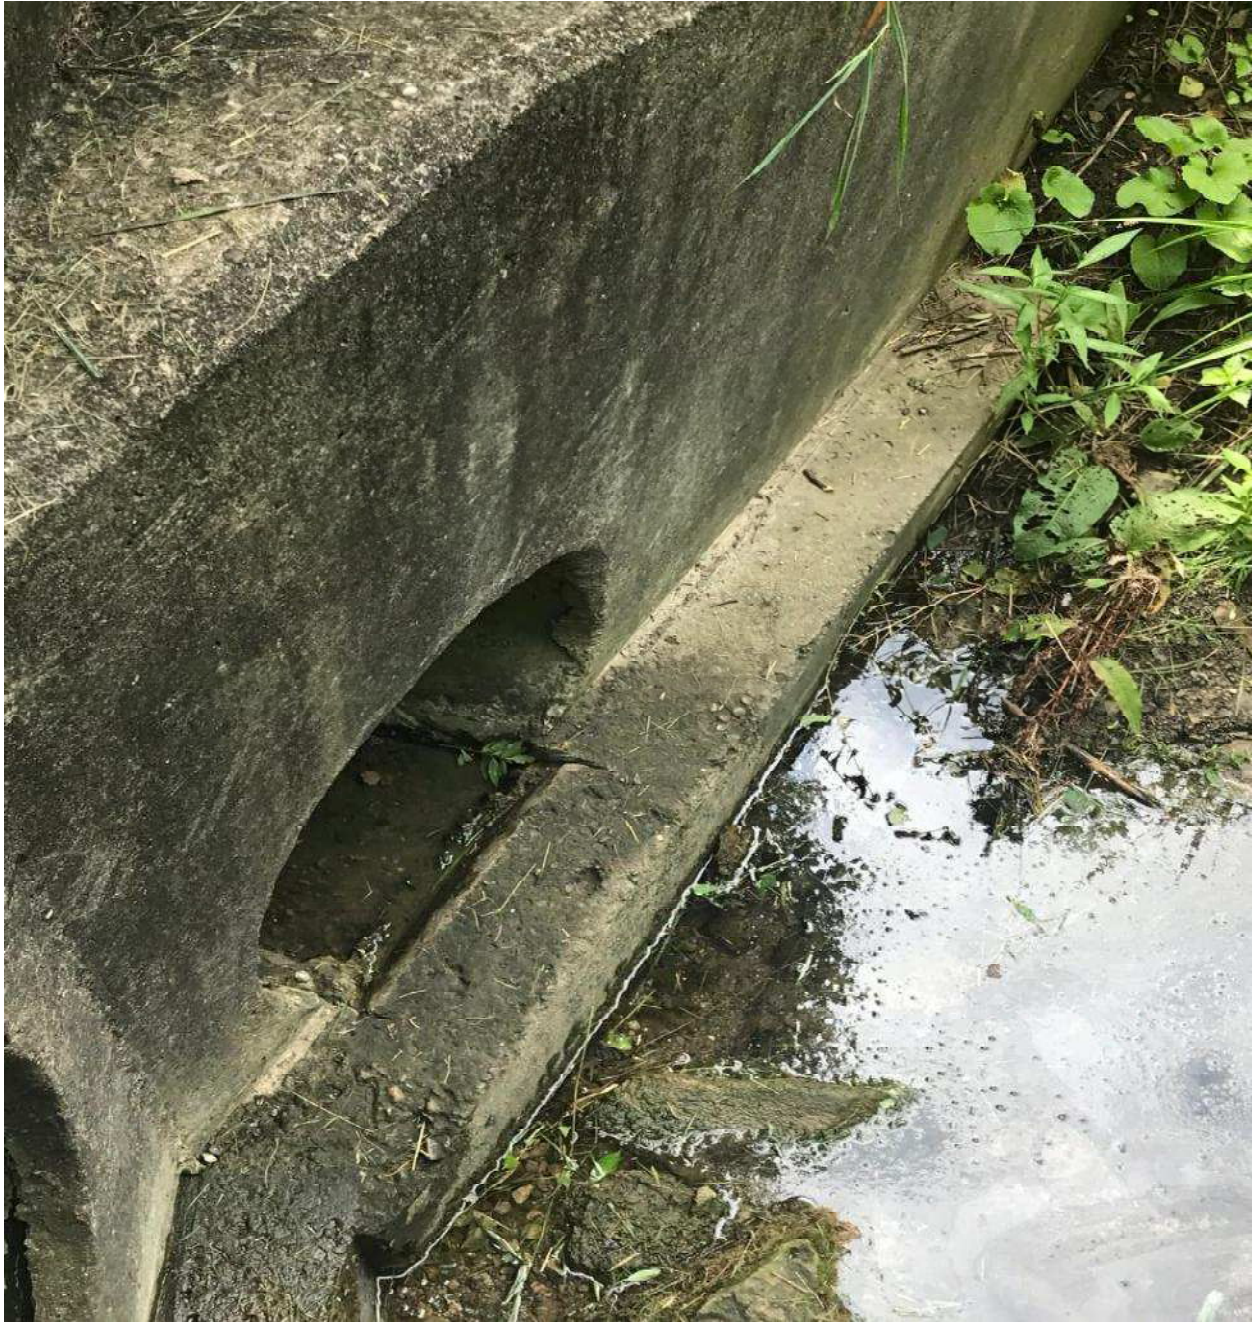
Outfall #8 of UNT #1 to the Monongahela River along Grand Boulevard

Outlets to the UNT #1 to the Monongahela River along Grand Boulevard. No flow during inspection. Pipe is located under City Park parking lot, and carries stormwater flow from inlet in parking lot and outlets into the stream channel. Recommend performing future inspections in the spring prior to heavy foliage and marking the location of the outlet pipe with paint or PennDOT approved delineator paddles along Grand Boulevard.

18" RCP

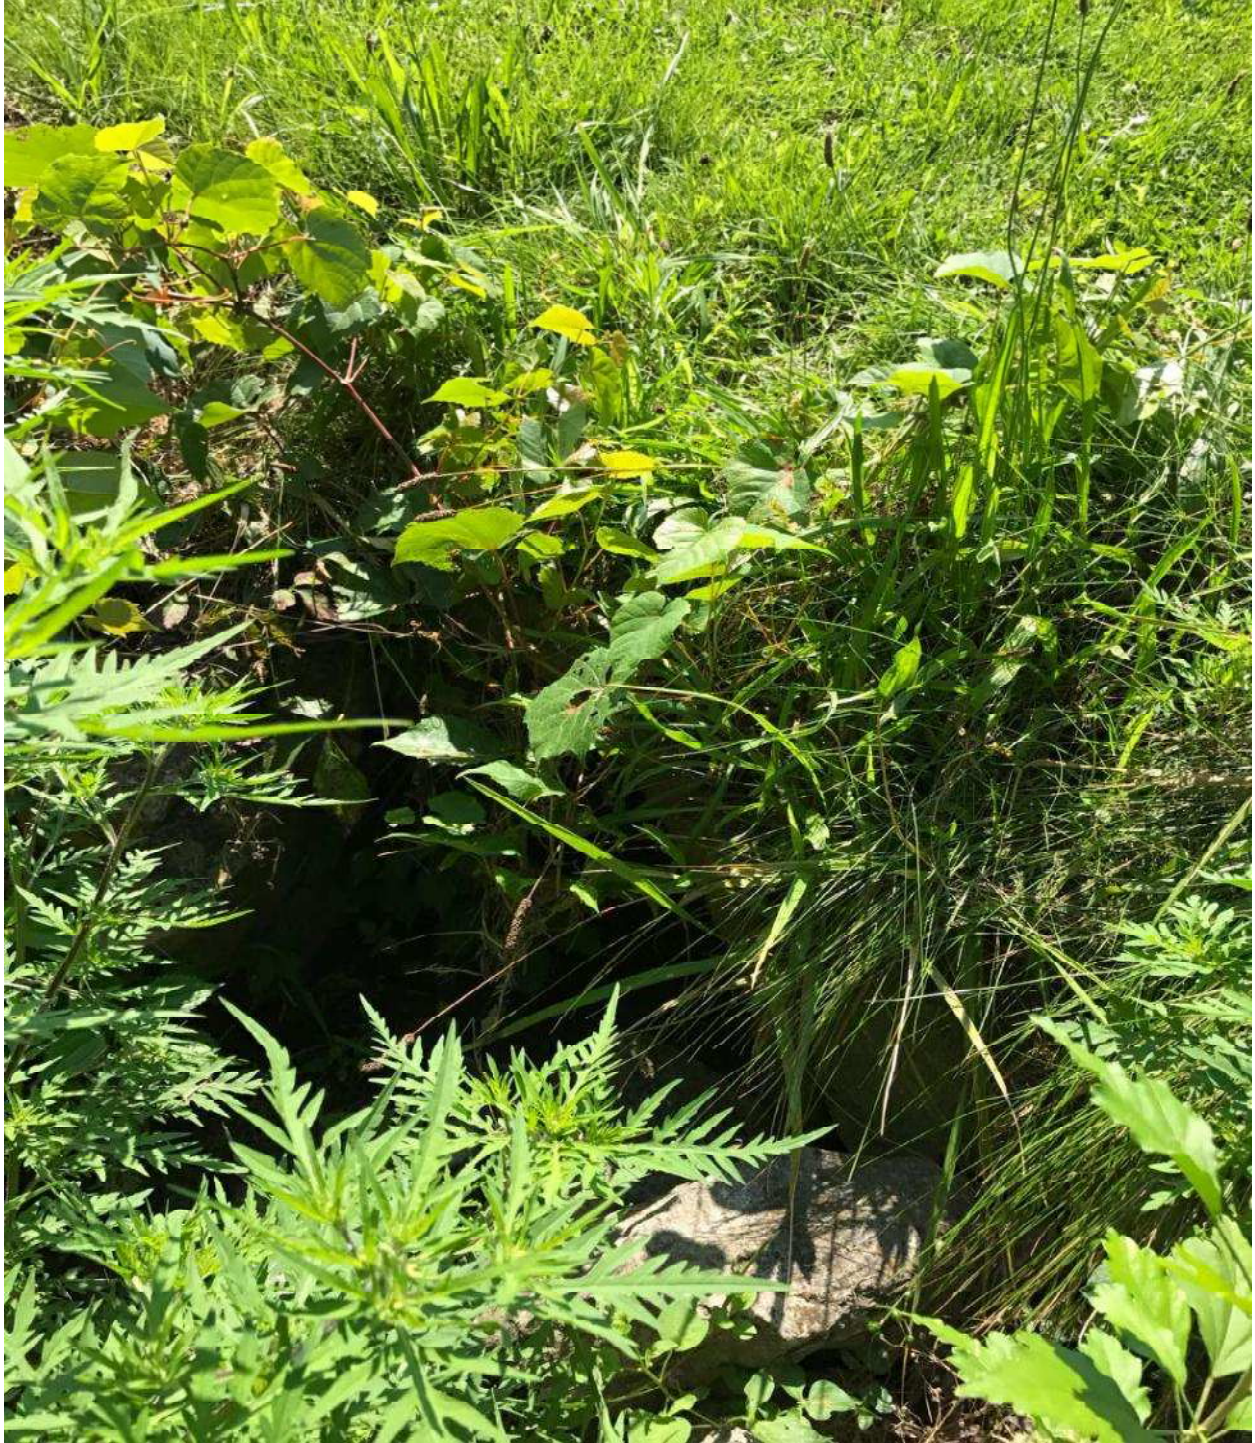
Outlets to the UNT #1 to the Monongahela River along Grand Boulevard. No flow during inspection. Pipe is located at the toe of grassed slope along the City Park Walking Track and carries stormwater flow from Grand Boulevard and outlets into the stream channel. Recommend performing future inspections in the spring prior to heavy foliage and marking the location of the outlet pipe with paint or PennDOT approved delineator paddles along Grand Boulevard.

Outfall #9 of UNT #1 to the Monongahela River along Grand Boulevard
15" CPP (View of obscured by heavy vegetation)

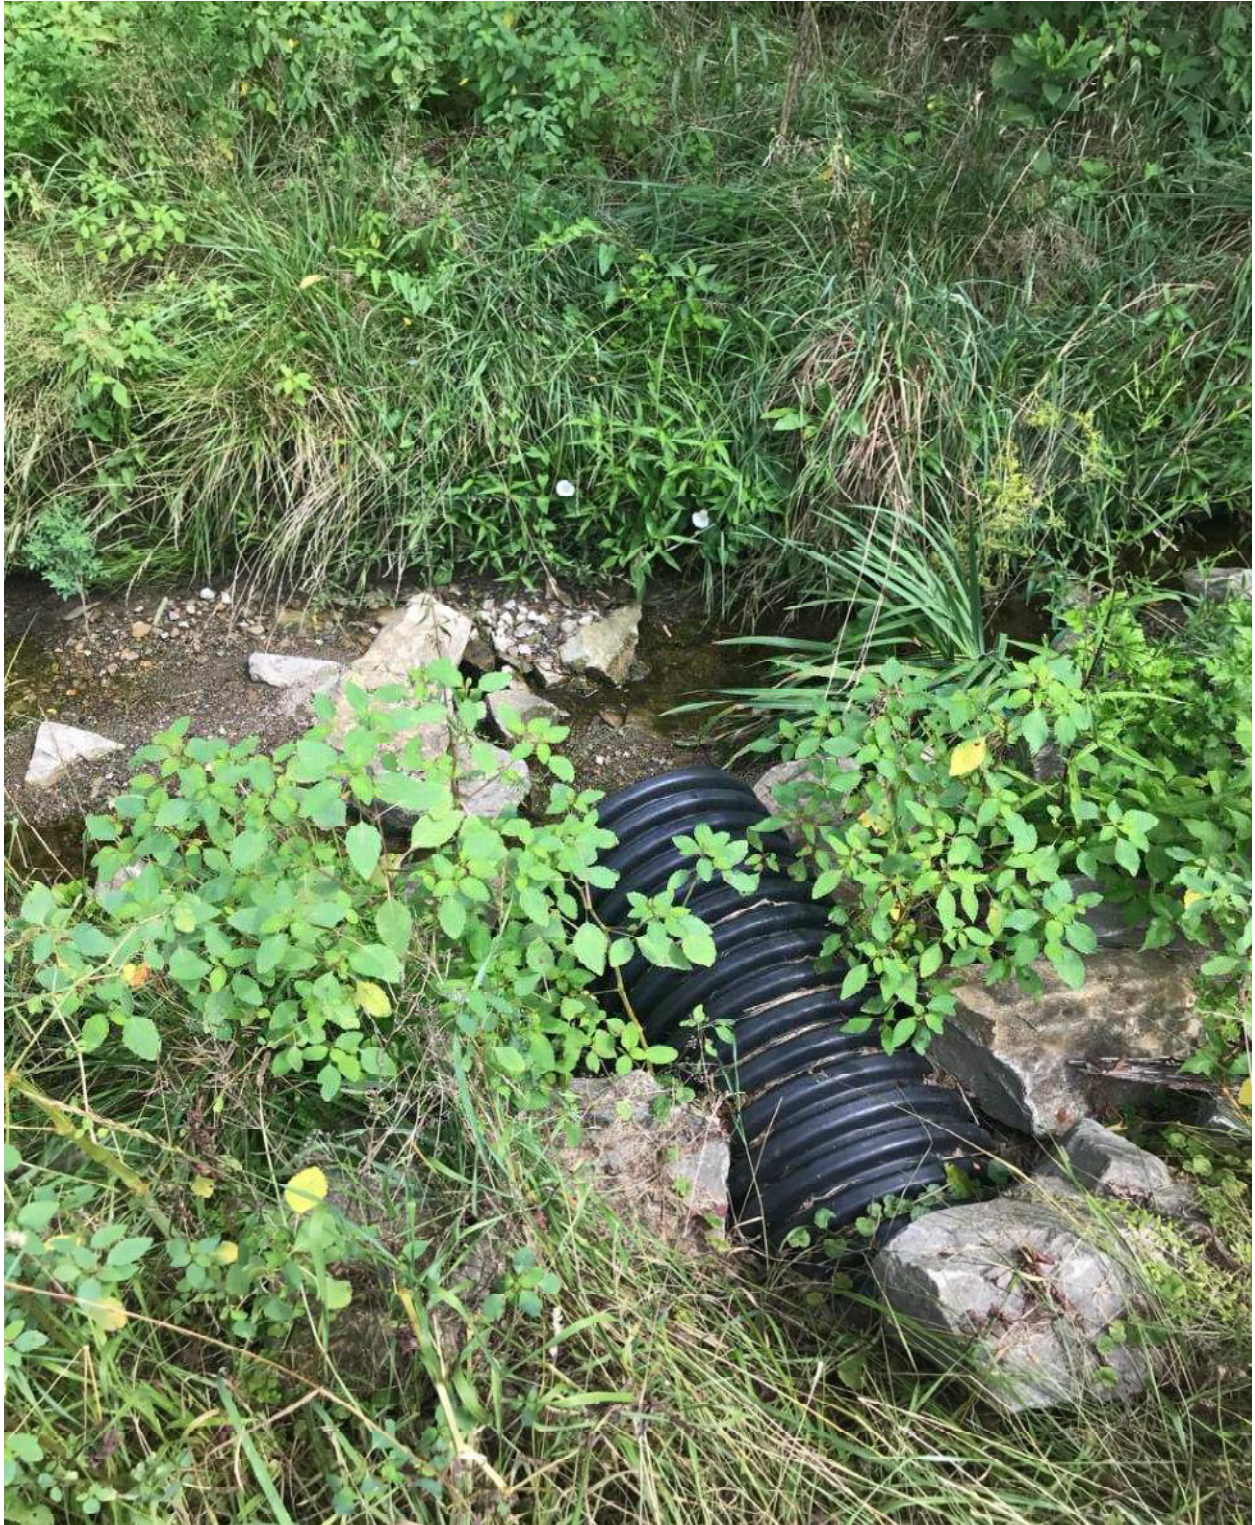
Outfall #10 of UNT #1 to the Monongahela River along Grand Boulevard

Inspector Comments:
Outlets to the UNT #1 to the Monongahela River along Grand Boulevard. No flow during inspection. Pipe is located at the toe of grassed slope along the City Park Walking Track and carries stormwater flow from Grand Boulevard and outlets into the stream channel. Recommend performing future inspections in the spring prior to heavy foliage and marking the location of the outlet pipe with paint or PennDOT approved delineator paddles along Grand Boulevard.

15" CPP

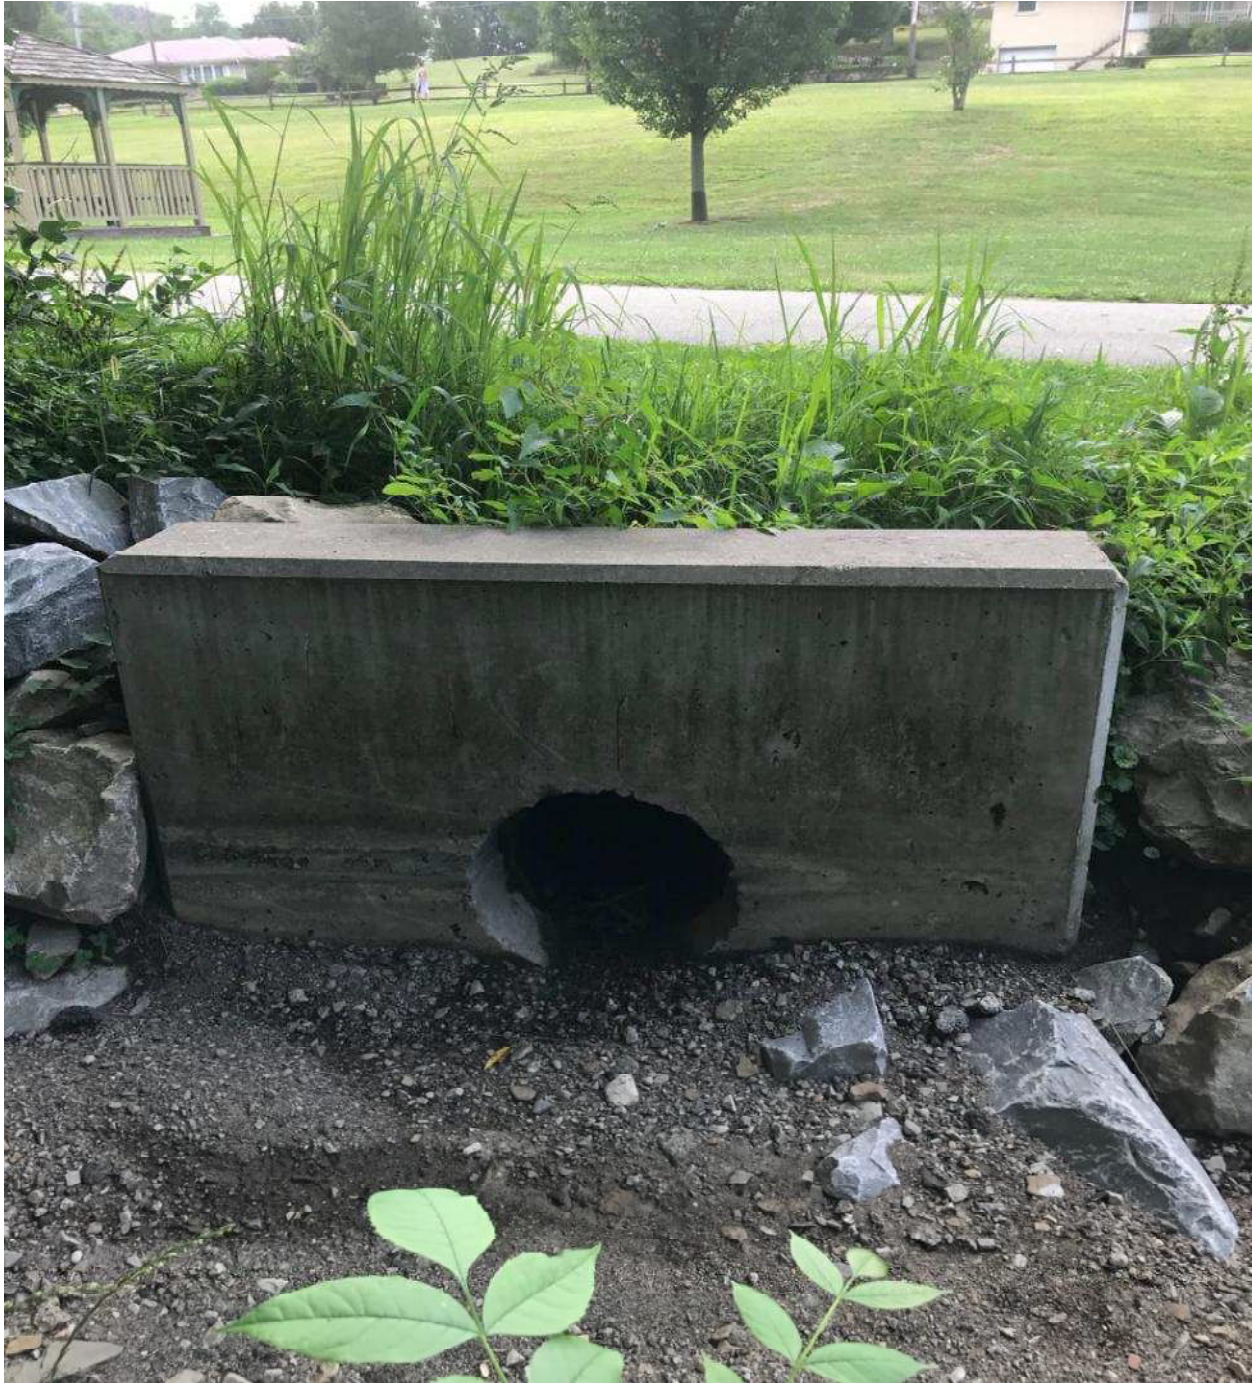
Outfall #11 of UNT #1 to the Monongahela River along Grand Boulevard

Inspector Comments:
Outlets to the UNT #1 to the Monongahela River along Grand Boulevard. No flow during inspection. Pipe is located at the toe of grassed slope along the City Park Walking Track and carries stormwater flow from Grand Boulevard and outlets into the stream channel. Recommend performing future inspections in the spring prior to heavy foliage and marking the location of the outlet pipe with paint or PennDOT approved delineator paddles along Grand Boulevard.

16" RCP

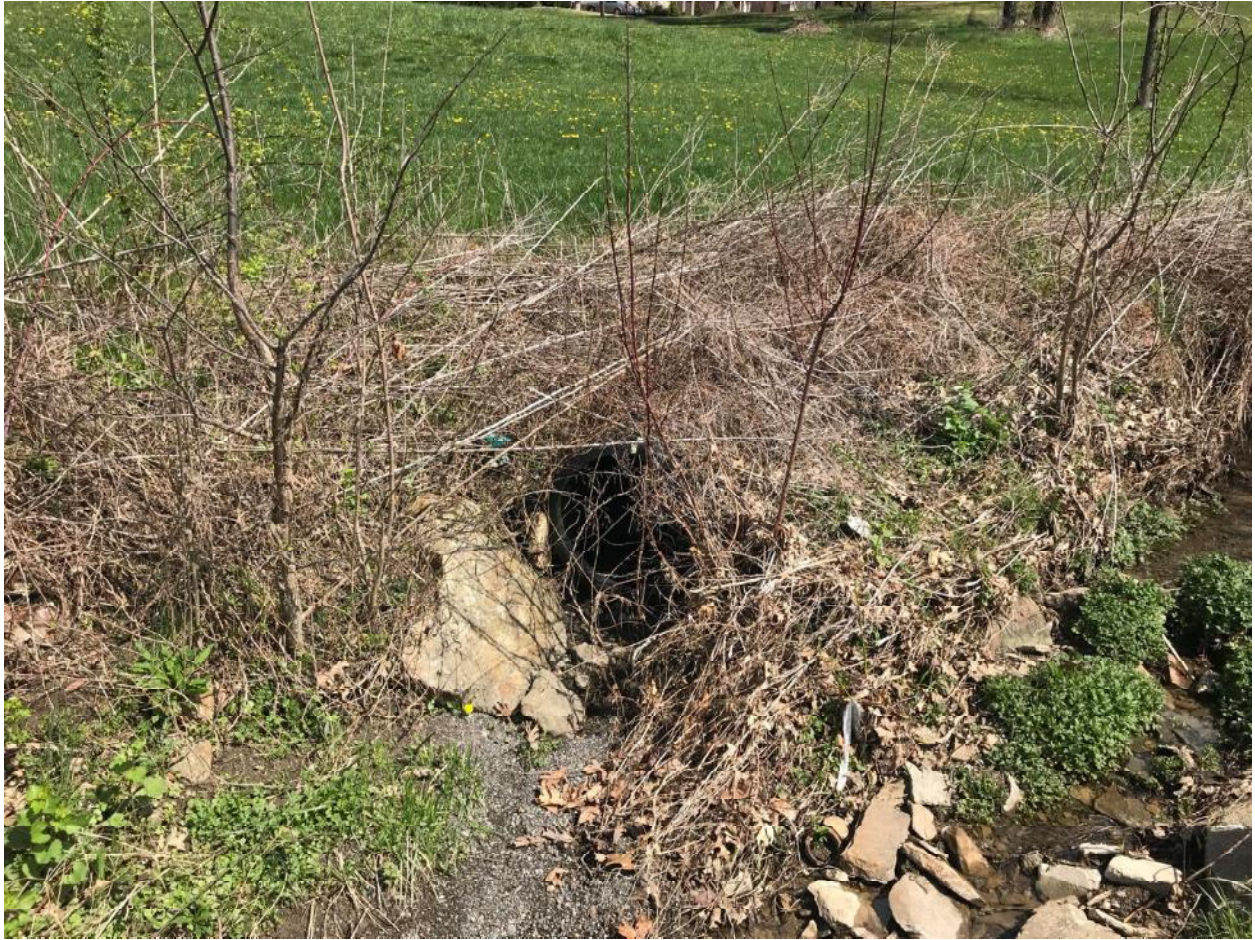
Outfall #12 of UNT #1 to the Monongahela River along Grand Boulevard

Outlets to the UNT #1 to the Monongahela River along Grand Boulevard. No flow during inspection. Pipe is located at the toe of grassed slope and carries stormwater flow from Euclid Avenue and outlets into the stream channel. Recommend performing future inspections in the spring prior to heavy foliage and marking the location of the outlet pipe with paint or PennDOT approved delineator paddles along Grand Boulevard.

24" CPP

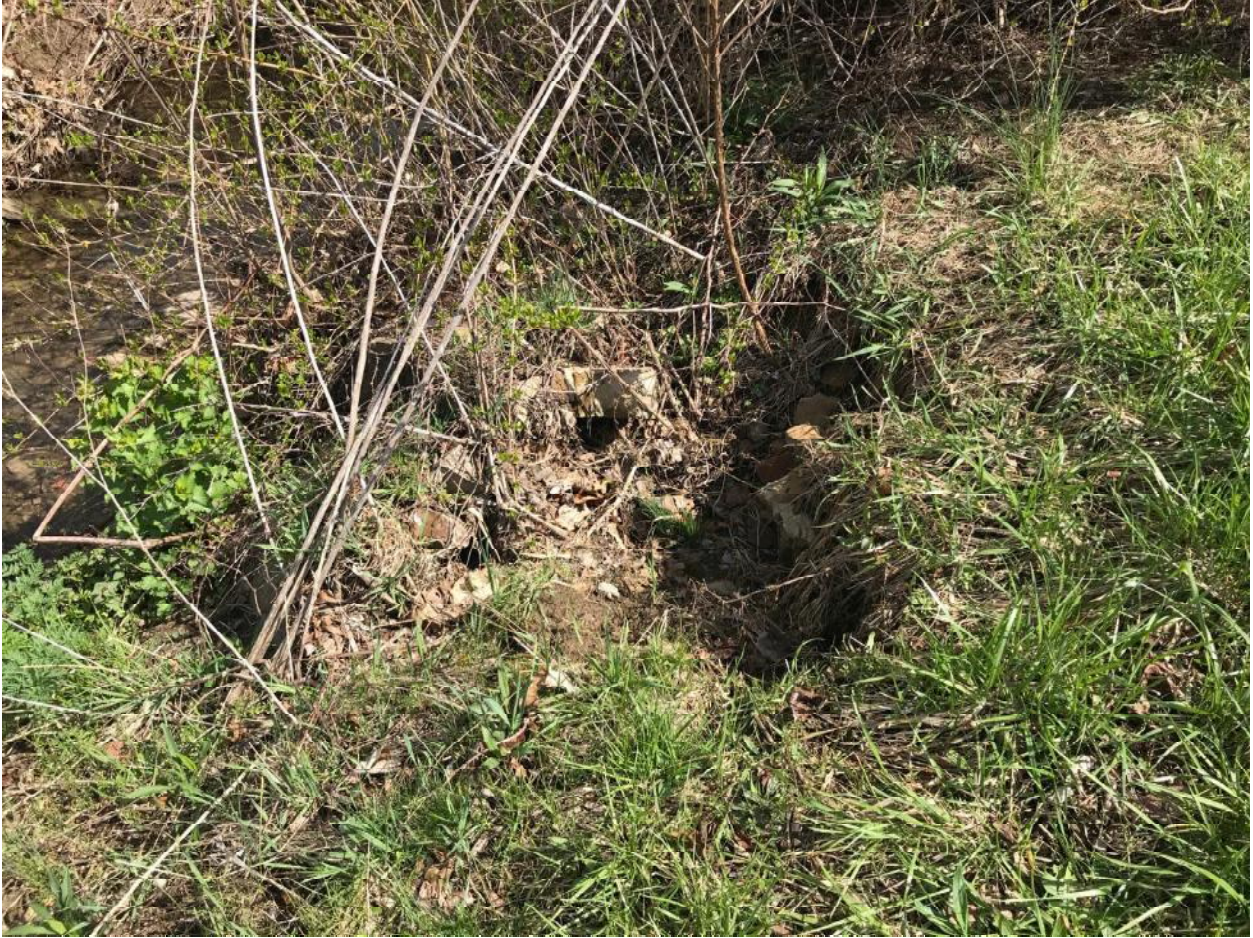
Outfall #13 of UNT #1 to the Monongahela River along Grand Boulevard

Outlets to the UNT #1 to the Monongahela River along Grand Boulevard. Pipe was found to be crushed and no flow during inspection. Pipe is located at the toe of grassed slope along the City Park Walking Track and carries stormwater flow from City Park and outlets into the stream channel. Recommend performing future inspections in the spring prior to heavy foliage and marking the location of the outlet pipe with paint or PennDOT approved delineator paddles along Grand Boulevard.

Terra Cota Pipe, size undetermined. Pipe was crushed at outfall.

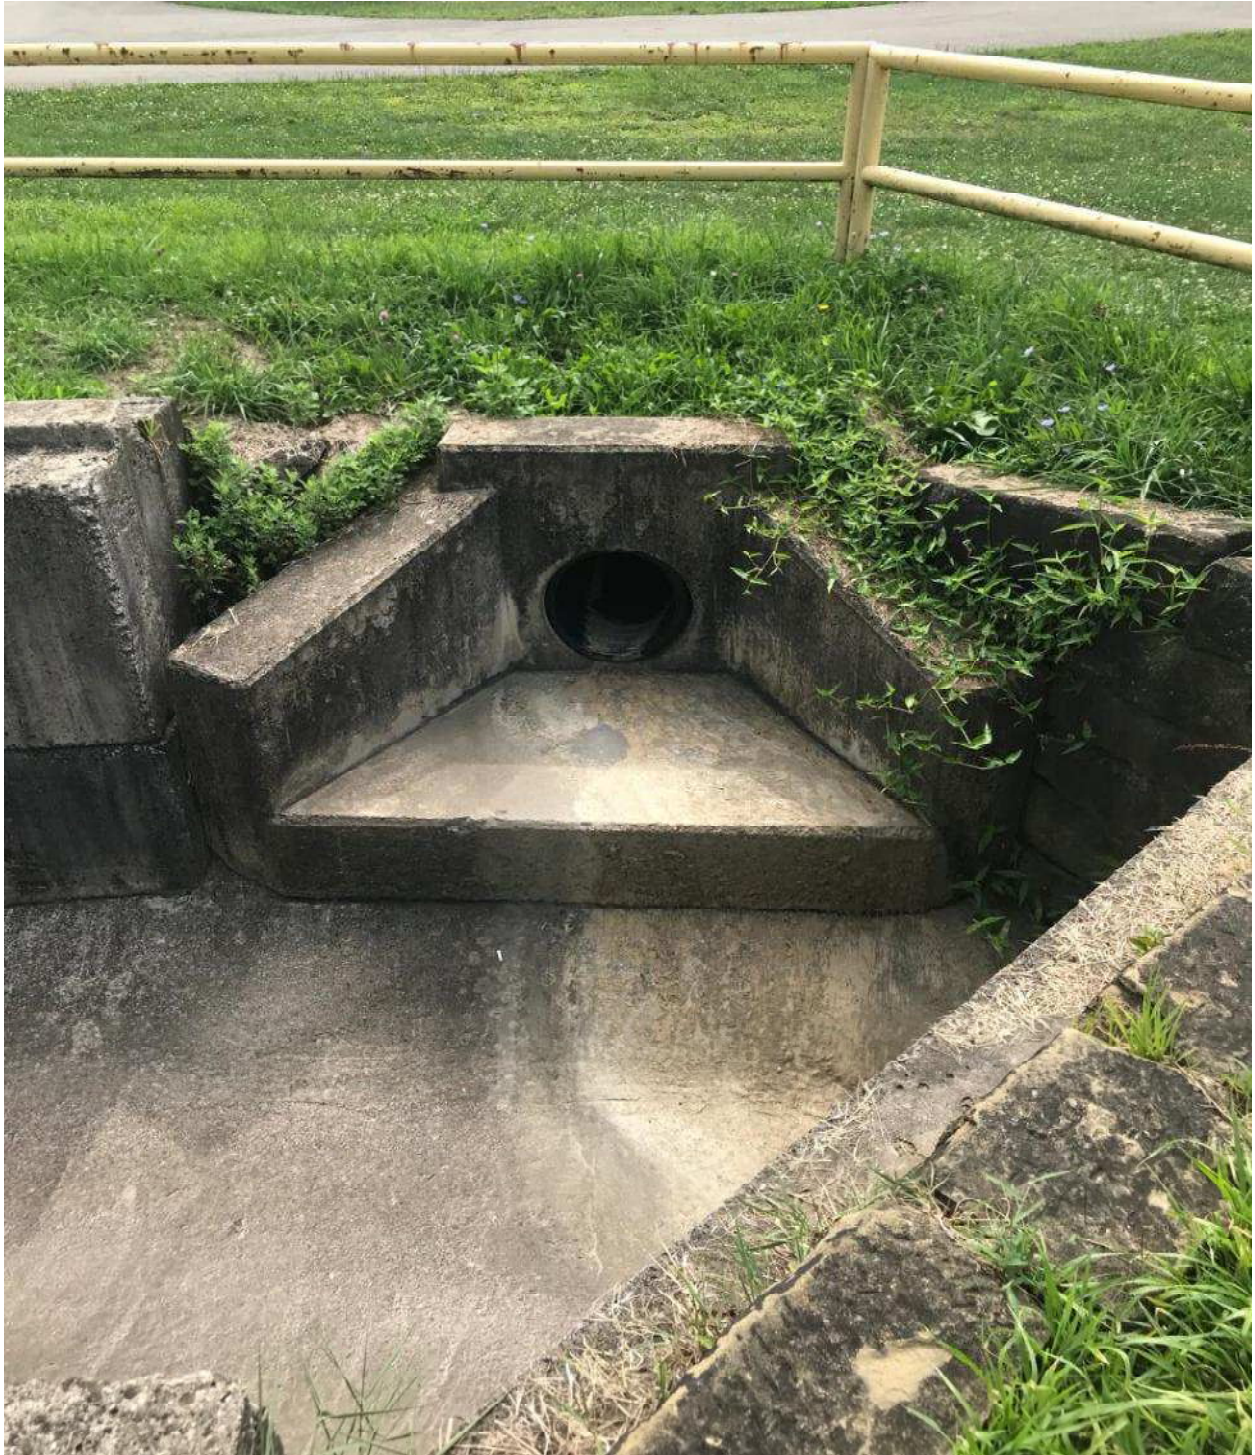
Outfall #14 of UNT #1 to the Monongahela River along Grand Boulevard

Outlets to the UNT #1 to the Monongahela River along Grand Boulevard. No flow during inspection. Pipe is located within the concrete headwall of the box culvert under Euclid Drive and carries stormwater flow from Grand Boulevard and outlets into the stream channel. Evidence of prior sediment deposition. No recommendations.

15" CMP

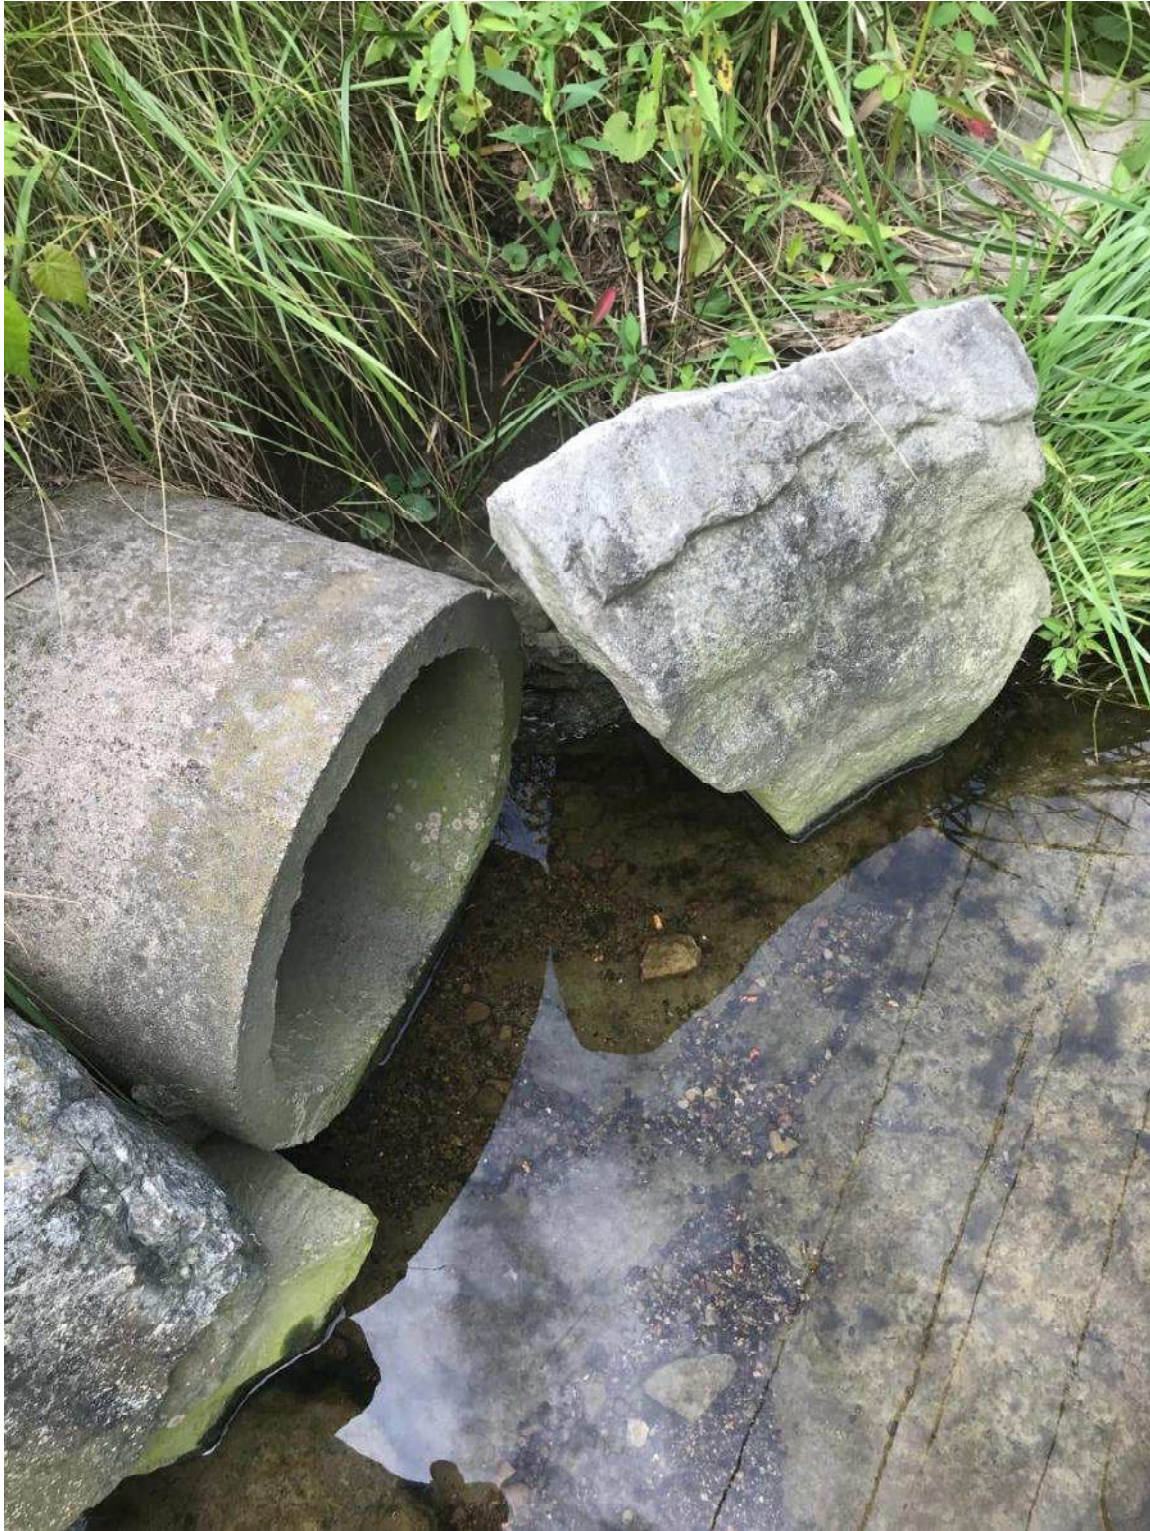
Outfall #15 of UNT #1 to the Monongahela River along Grand Boulevard

Outlets to the UNT #1 to the Monongahela River along Grand Boulevard. No flow during inspection. Pipe is located at the toe of grassed slope and carries stormwater flow from Grand Boulevard and outlets into the stream channel. Recommend performing future inspections in the spring prior to heavy foliage and marking the location of the outlet pipe with paint or PennDOT approved delineator paddles along Grand Boulevard.

15" RCP

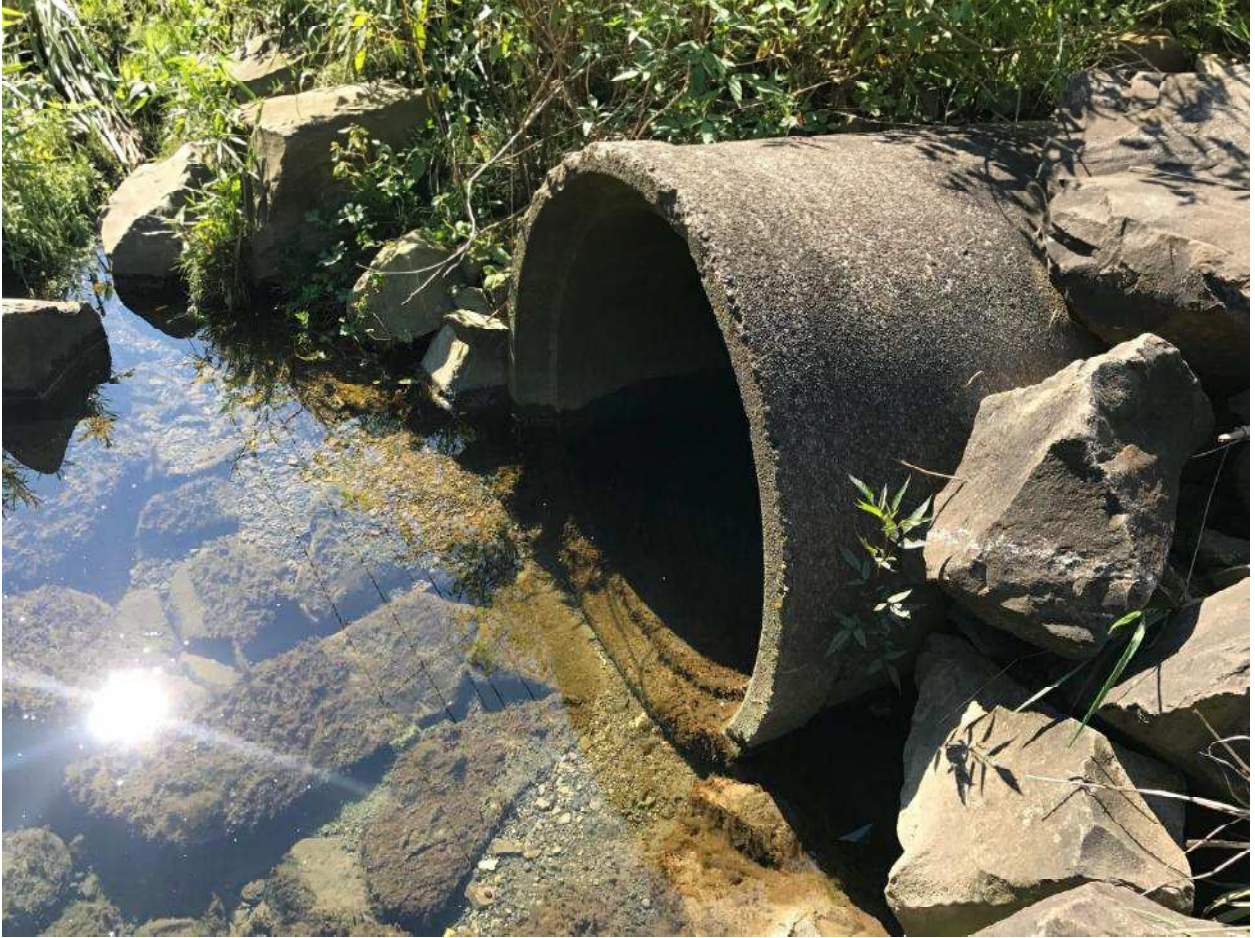
Outfall #16 of UNT #1 to the Monongahela River along Grand Boulevard

Outlets to the UNT #1 to the Monongahela River along Grand Boulevard. Pipe is submerged in water, therefore it we were unable to determine flow during inspection. Pipe is located at the toe of grassed slope and carries stormwater flow from Monessen Boulevard and outlets into the stream channel. Recommend performing future inspections in the spring prior to heavy foliage and marking the location of the outlet pipe with paint or PennDOT approved delineator paddles along Grand Boulevard.

36" RCP
