MS4 OUTFALL FIELD SCREENING REPORT

UNT#2 to the Monongahela River Outfall Screening Reports

UNT to Speers Run Outfall Screening Reports

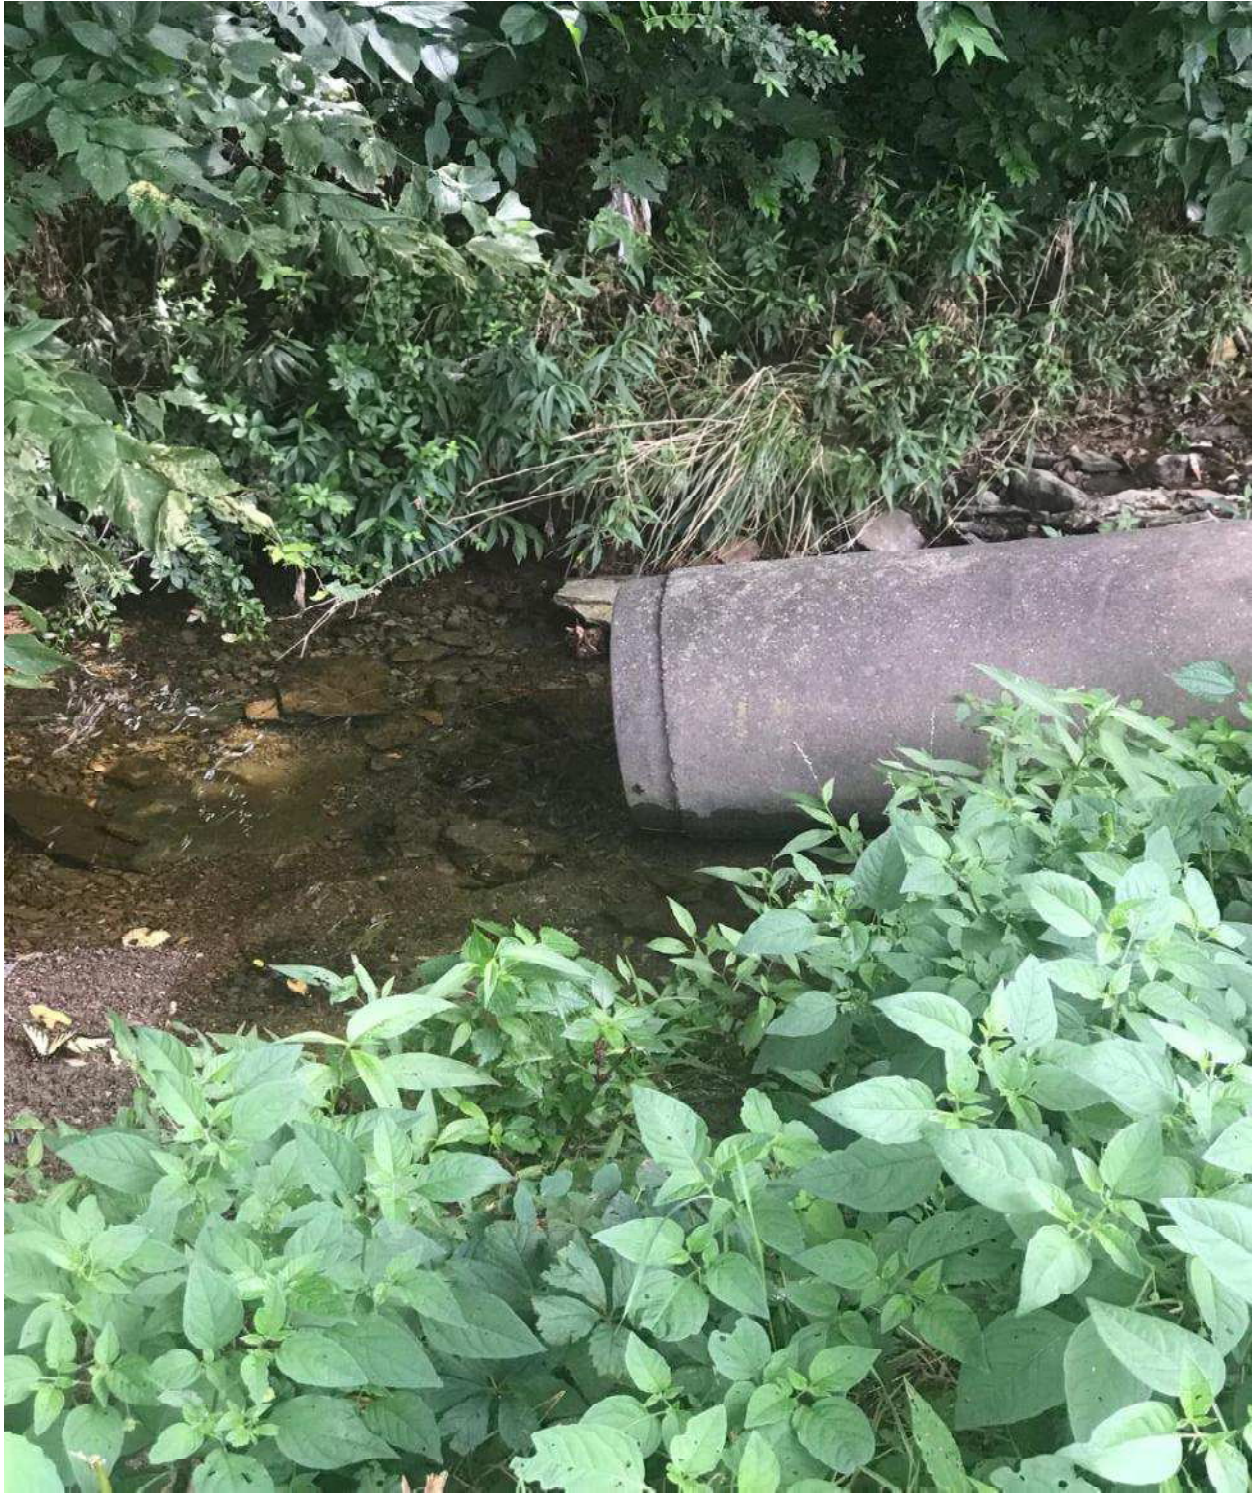
Outfall #17 of UNT #1 to the Monongahela River along Grand Boulevard

Outlets to the UNT #1 to the Monongahela River along Grand Boulevard. No flow during inspection. Pipe is located at the toe of grassed slope and carries stormwater flow from Grand Boulevard and outlets into the stream channel. Recommend performing future inspections in the spring prior to heavy foliage and marking the location of the outlet pipe with paint or PennDOT approved delineator paddles along Grand Boulevard. Also, pipe end section should be removed to prevent pipe from blocking stream flow.

18" RCP

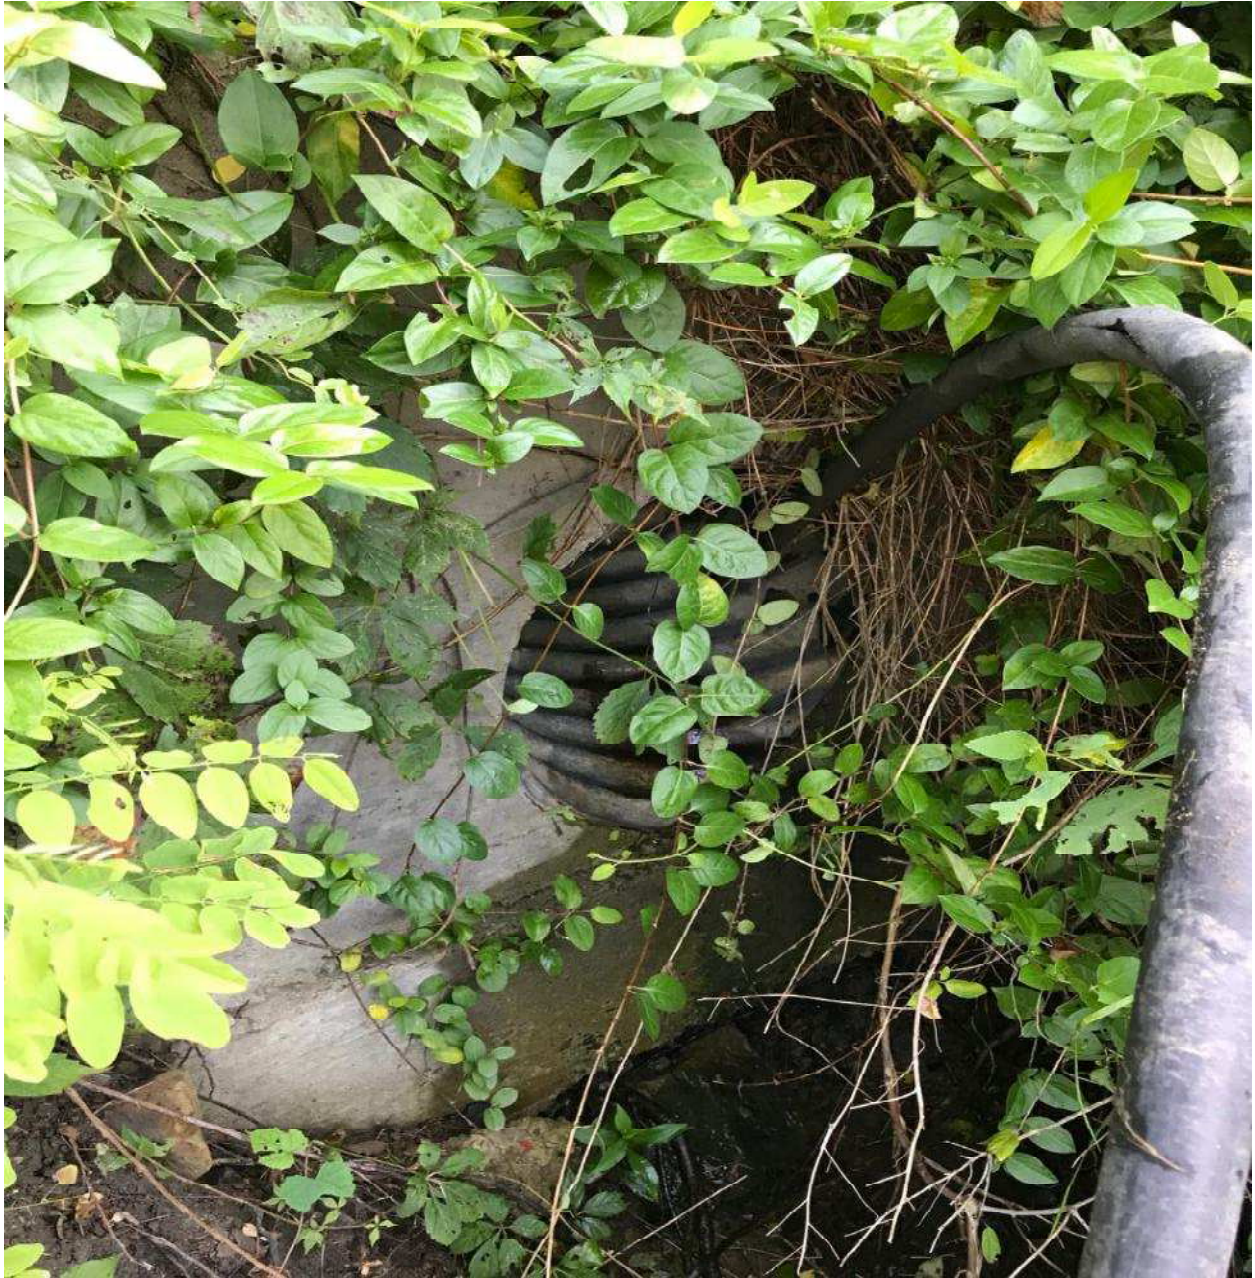
Outfall #18 of UNT #1 to the Monongahela River along Grand Boulevard

Outlets to the UNT #1 to the Monongahela River along Grand Boulevard. Trickle flow during inspection. Pipe is located at the toe of wooded slope and carries stormwater flow from Shaw Drive and outlets into the stream channel. Mild erosion at the outfall. Recommend performing future inspections in the spring prior to heavy foliage and marking the location of the outlet pipe with paint or PennDOT approved delineator paddles along Grand Boulevard and place rock stabilization at outfall.

18" CMP

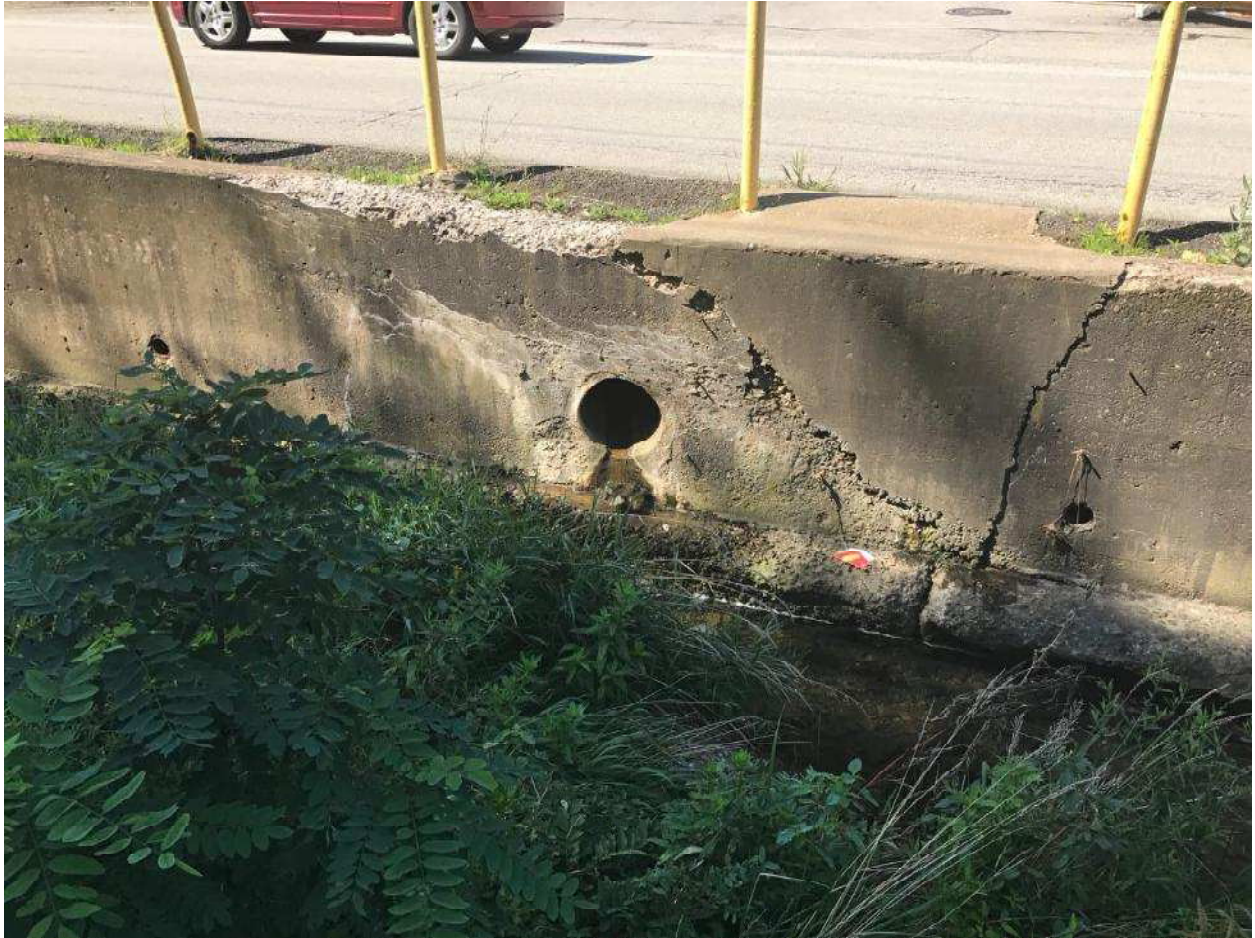
Outfall #19 of UNT #1 to the Monongahela River along Grand Boulevard

Whitish discharge in flow, along with benthic growth in pipe and outfall

Potential illicit discharge that will need further testing

Outlets to the UNT #1 to the Monongahela River along Grand Boulevard. Trickle flow during inspection. Pipe is located within concrete wall along Grand Boulevard. Pipe carries stormwater flow from Plaza parking lot and outlets into the stream channel. Recommend performing future inspections in the spring prior to heavy foliage and marking the location of the outlet pipe with paint or PennDOT approved delineator paddles along Grand Boulevard and further testing of flow.

16" RCP (potential illicit discharge)

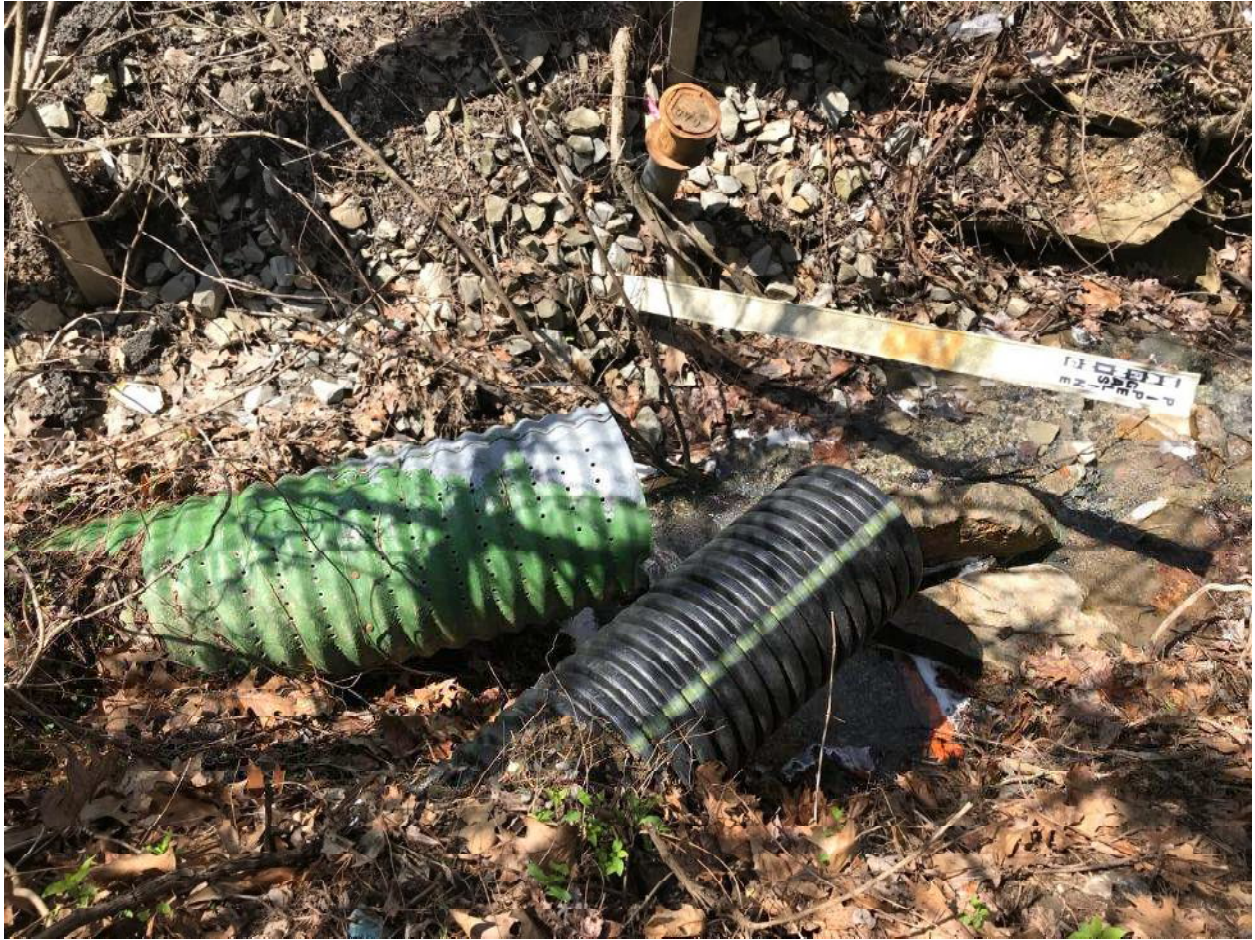
Outfall #1 of UNT #2 to the Monongahela River along Tyrol Boulevard

White precipitate within water from upstream mine drainage along Tyrol Boulevard

White precipitate at outfall, but quickly dissipates once introduced to other water downstream

Mine drainage upstream of outfall along Tyrol Boulevard

Outlets to the UNT #2 to the Monongahela River along Tyrol Boulevard. Steady to moderate flow during inspection. Flow is attributed to natural springs and mine drainage feeding the stormwater lines along Tyrol Boulevard. Recommend performing future inspections in the spring prior to heavy foliage and marking the location of the outlet pipe with paint or PennDOT approved delineator paddles along Tyrol Boulevard.

18" CMP

Contacted DEP Mining office to develop a course of action. A Hydrodynamic separator planned for this area under the approved Pollution Reduction Plan.

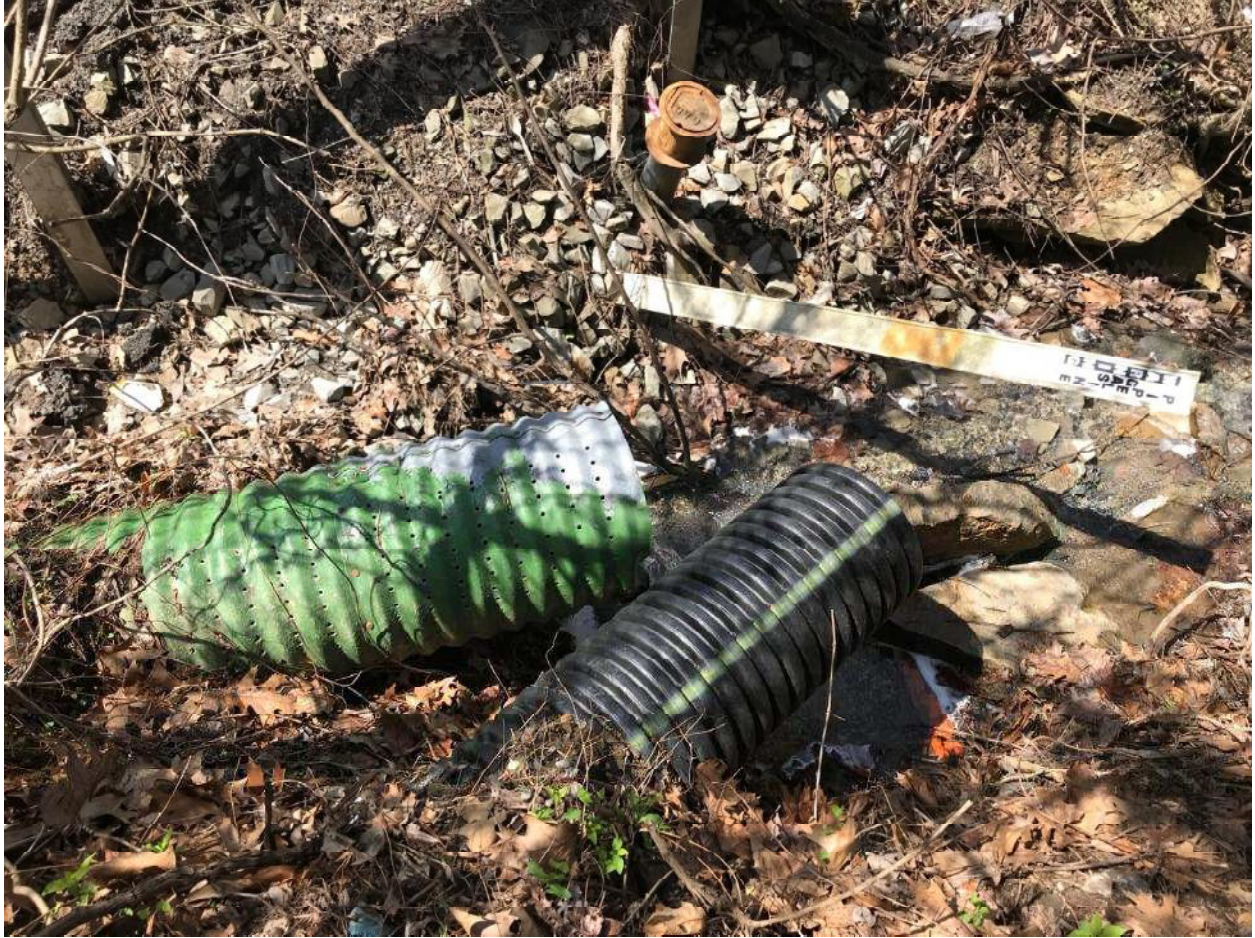
Outfall #2 of UNT #2 to the Monongahela River along Tyrol Boulevard

Outlets to the UNT #2 to the Monongahela River along Tyrol Boulevard. No flow during inspection. Pipe carries stormwater flow from Tyrol Boulevard and outlets into the stream channel. Recommend performing future inspections in the spring prior to heavy foliage and marking the location of the outlet pipe with paint or PennDOT approved delineator paddles along Tyrol Boulevard.

12" CPP

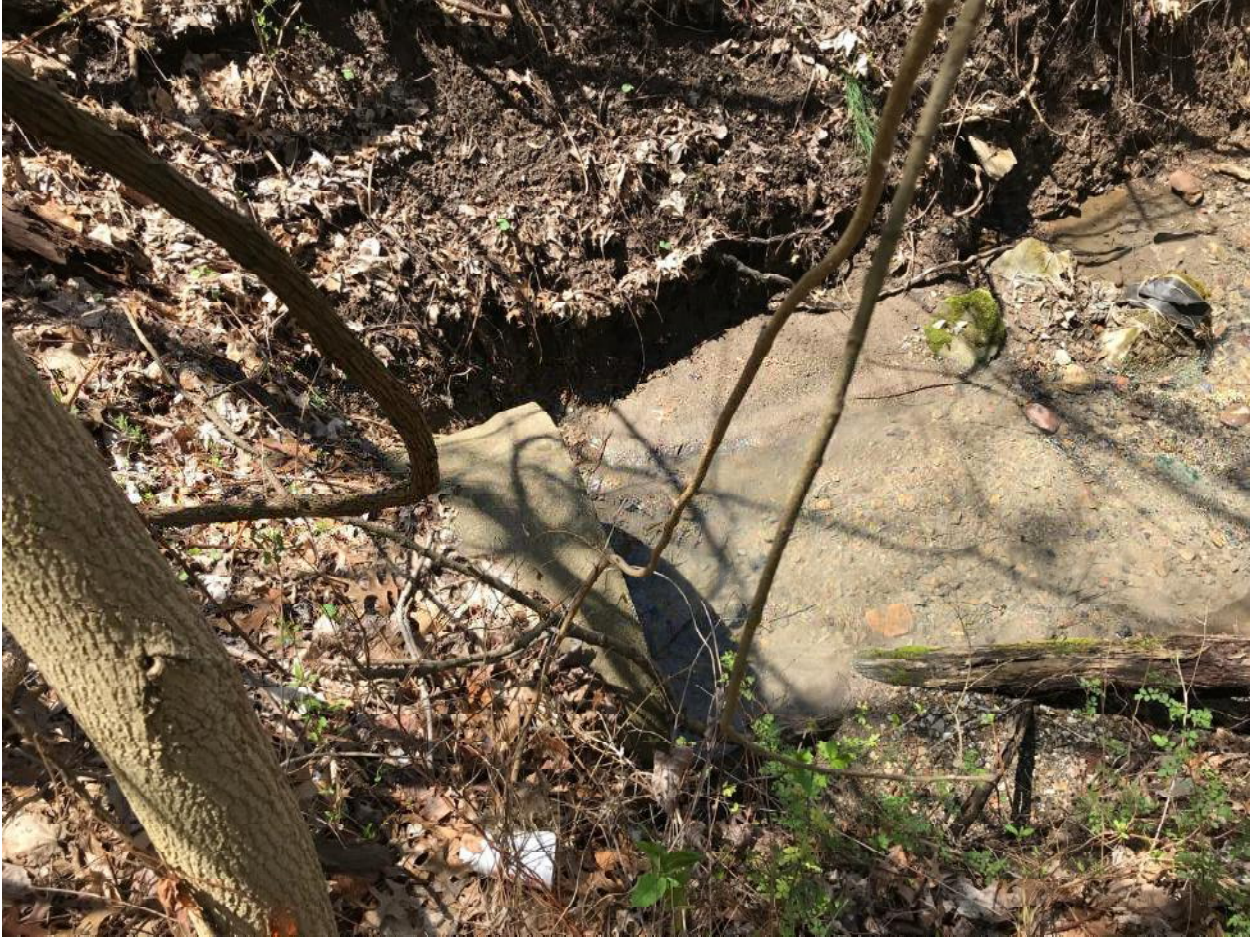
Outfall #3 of UNT #2 to the Monongahela River along Tyrol Boulevard

Outlets to the UNT #2 to the Monongahela River along Tyrol Boulevard. No flow during inspection. Pipe carries stormwater flow from Rostraver Apartments and outlets into the stream channel. Recommend performing future inspections in the spring prior to heavy foliage and marking the location of the outlet pipe with paint or PennDOT approved delineator paddles.

36" RCP

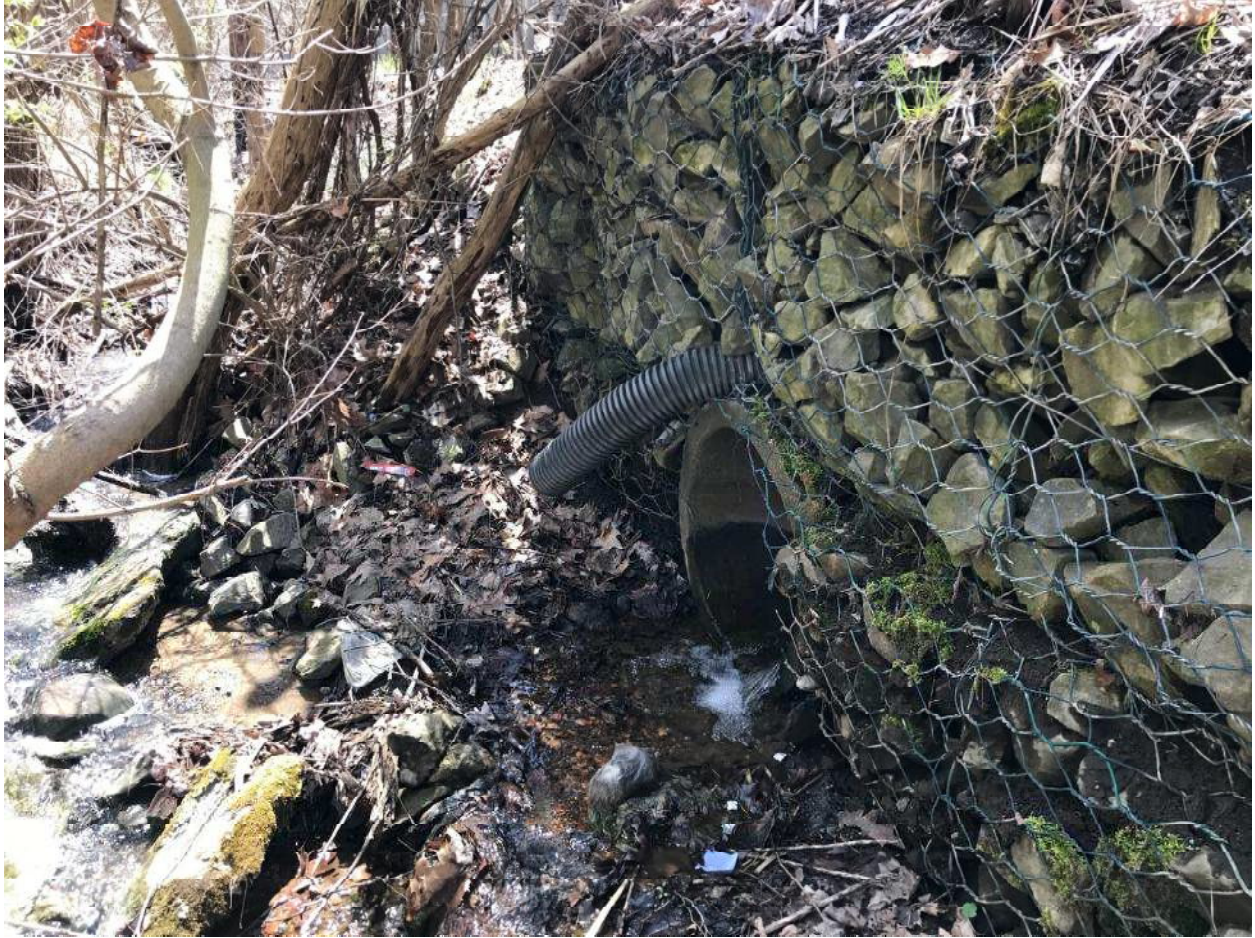
Outfall #4 of UNT #2 to the Monongahela River along Tyrol Boulevard

Orange precipitate within water from upstream mine drainage along Tyrol Boulevard

Orange precipitate at outfall, but quickly dissipates once introduced to other water downstream

Mine drainage upstream of outfall along Tyrol Boulevard

Outlets to the UNT #2 to the Monongahela River along Tyrol Boulevard. Steady flow during inspection. Flow is attributed to natural springs and mine drainage feeding the stormwater lines along Tyrol Boulevard. Recommend performing future inspections in the spring prior to heavy foliage and marking the location of the outlet pipe with paint or PennDOT approved delineator paddles along Tyrol Boulevard.

24" RCP

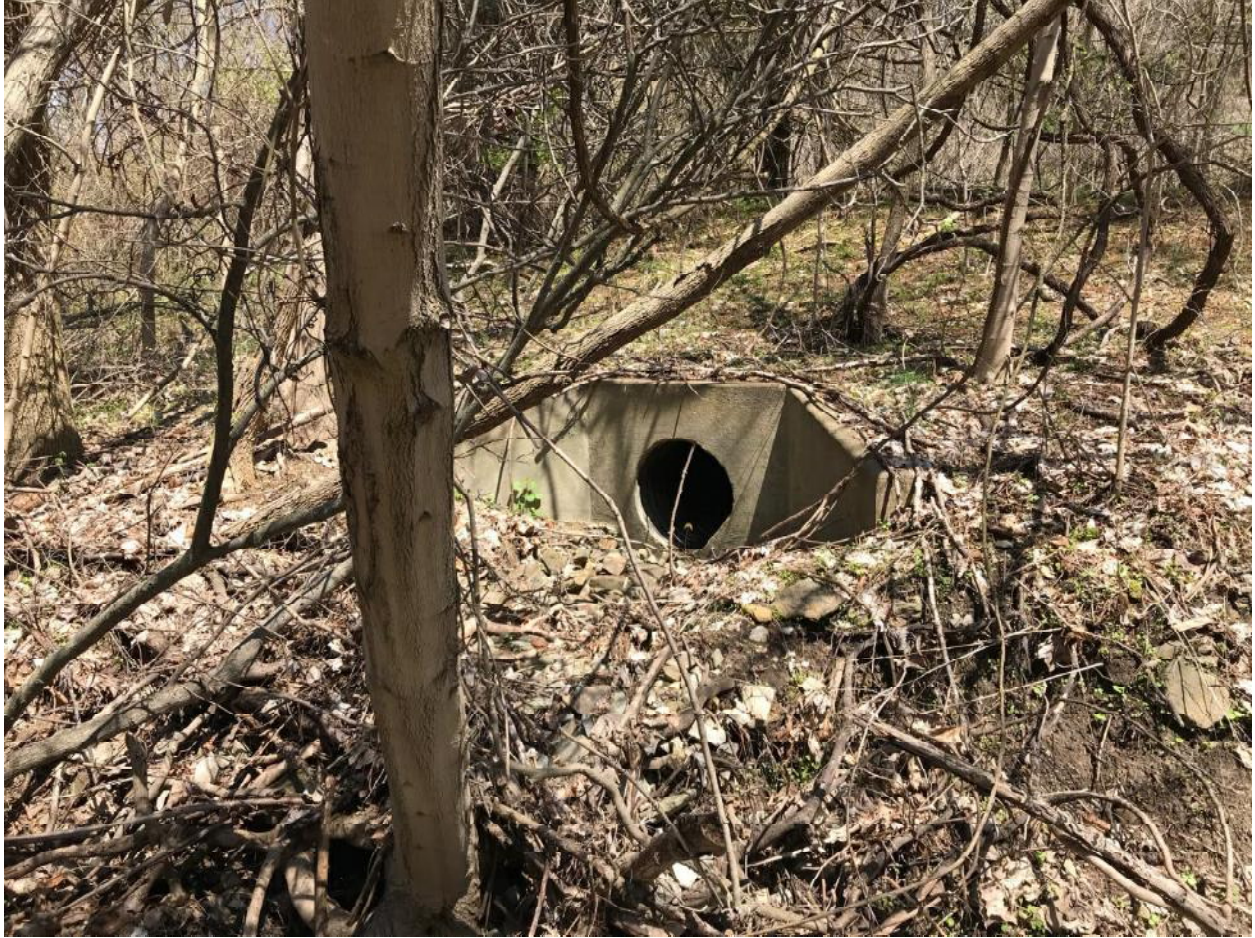
Outfall #5 of UNT #2 to the Monongahela River along Tyrol Boulevard

Outlets to the UNT #2 to the Monongahela River along Tyrol Boulevard. No flow during inspection. Origin of pipe undetermined and located in Rostraver Township. Recommend performing future inspections in the spring prior to heavy foliage and marking the location of the outlet pipe with paint or PennDOT approved delineator paddles to make more visible from Tyrol Boulevard.

24" RCP

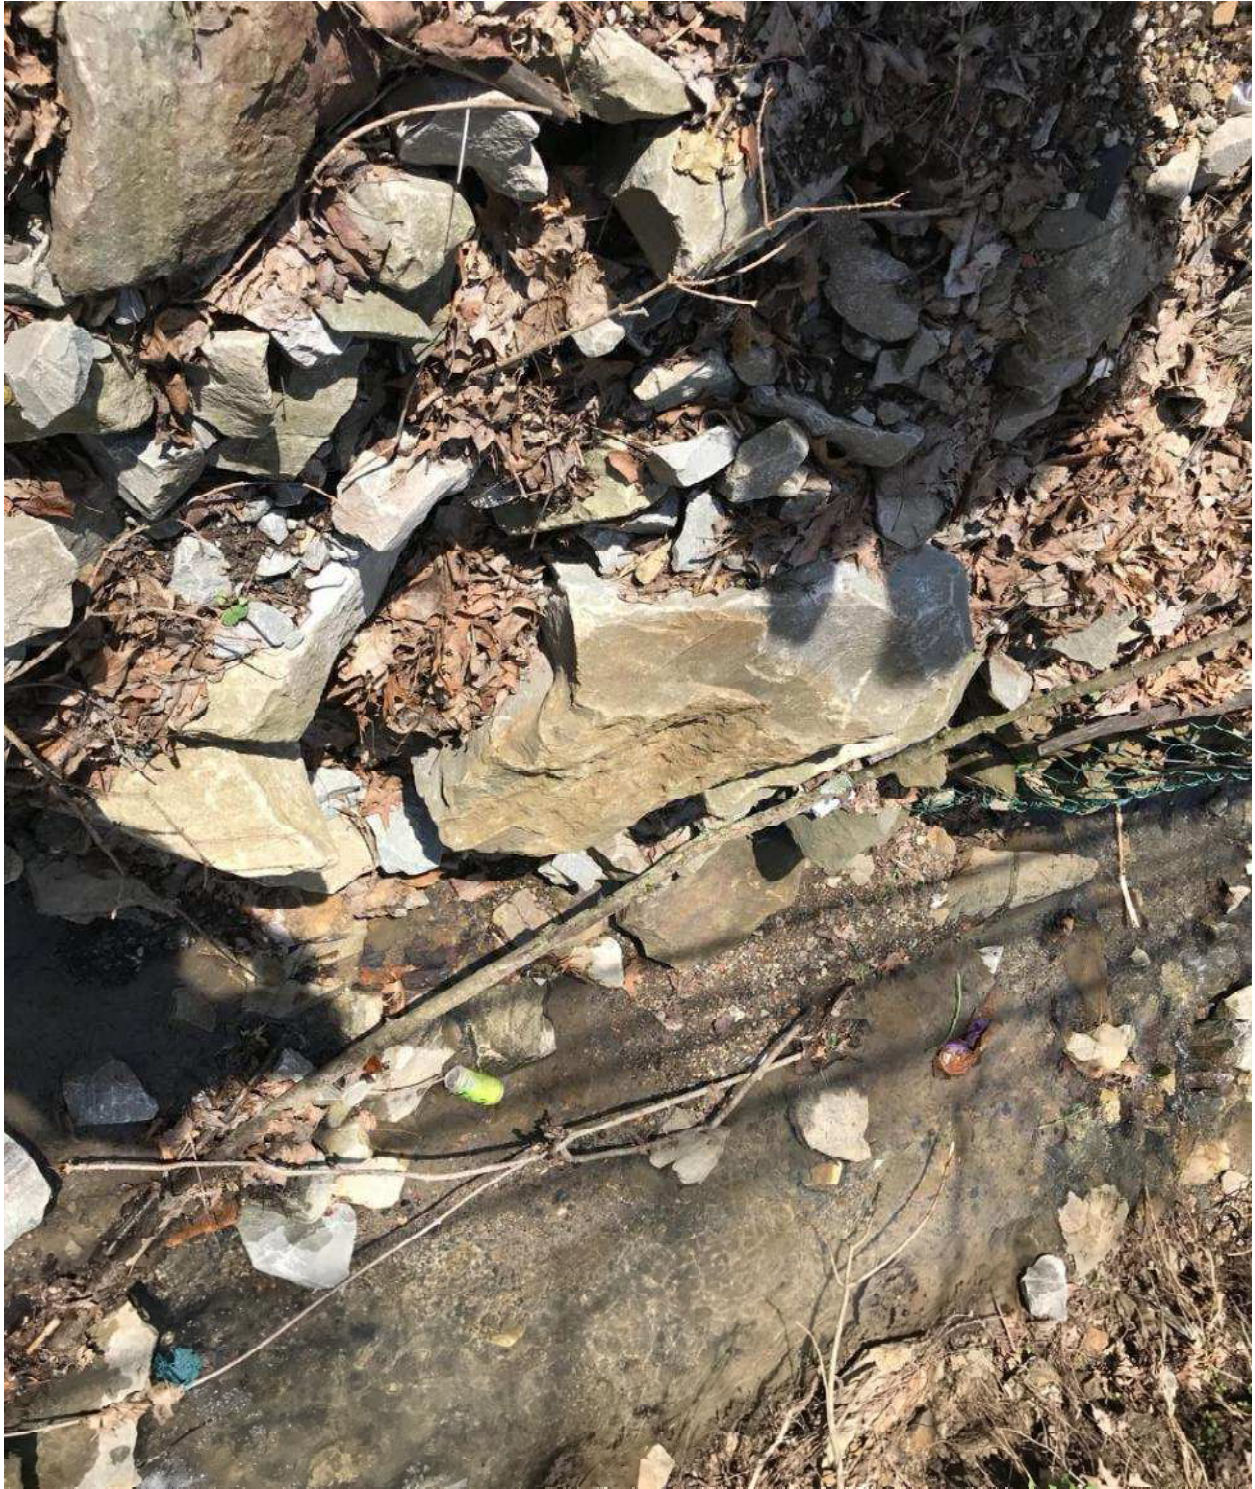
Outfall #6 of UNT #2 to the Monongahela River along Tyrol Boulevard

Outlets to the UNT #2 to the Monongahela River along Tyrol Boulevard. No flow during inspection. Pipe outfall located behind riprap dumped along roadway to stabilize channel. Pipe carries stormwater flow from Tyrol Boulevard and outlets into the stream channel. Recommend performing future inspections in the spring prior to heavy foliage and marking the location of the outlet pipe with paint or PennDOT approved delineator paddles along Tyrol Boulevard.

18" RCP (covered with riprap)

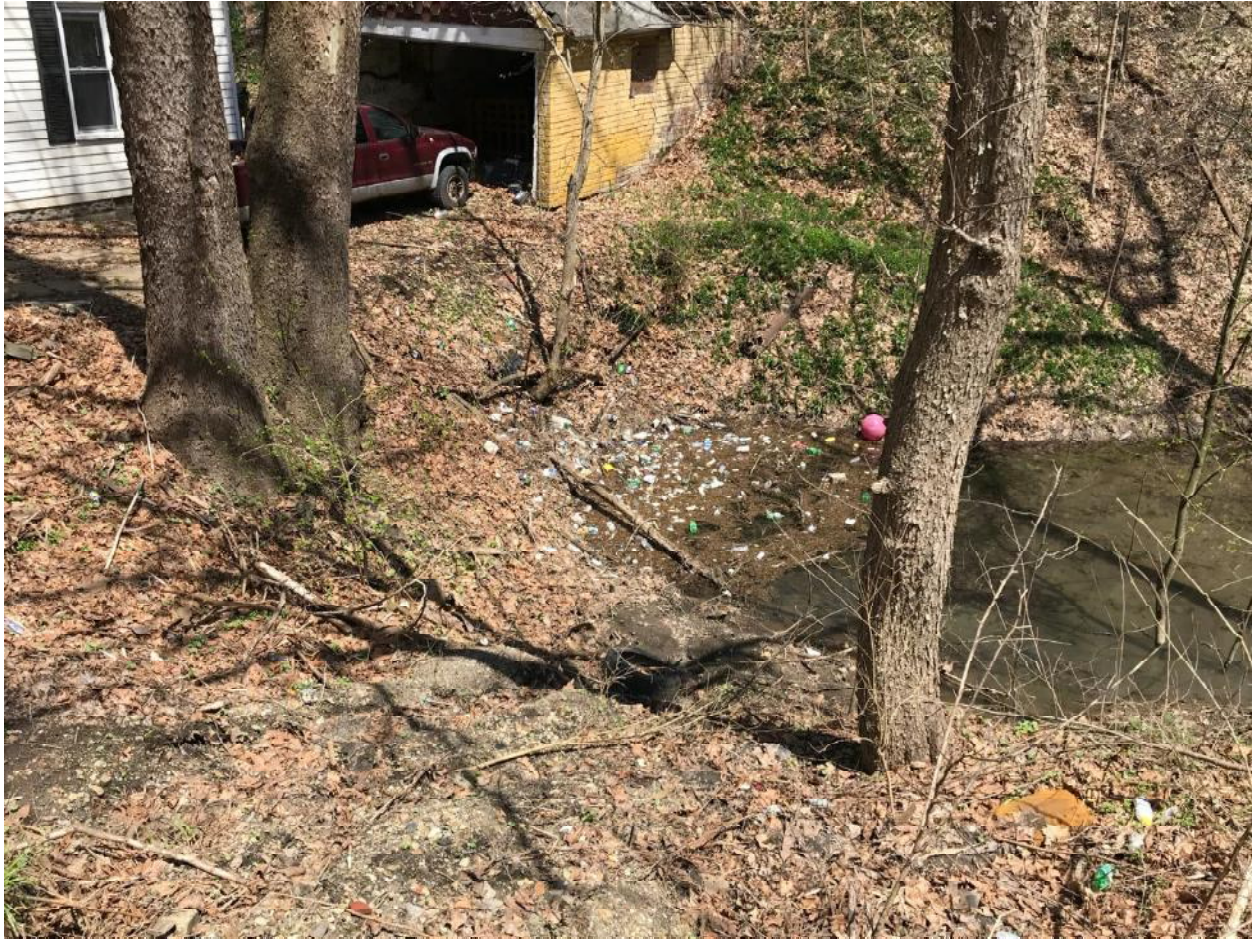
Outfall #7 of UNT #7 to the Monongahela River along Tyrol Boulevard
24" RCP (submerged in water/sediment at toe of slope)

Outlets to the UNT #2 to the Monongahela River along Tyrol Boulevard. Unable to determine if flow was present during inspection, but no upstream flow present. Pipe outfall not clearly visible due to heavy sediment and garbage deposition in the area. Pipe carries stormwater flow from Tyrol Boulevard and outlets into the stream channel. Recommend performing future inspections in the spring prior to heavy foliage and marking the location of the outlet pipe with paint or PennDOT approved delineator paddles along Tyrol Boulevard. City needs to remove sediment and debris from both inlet and outlet of pipe.

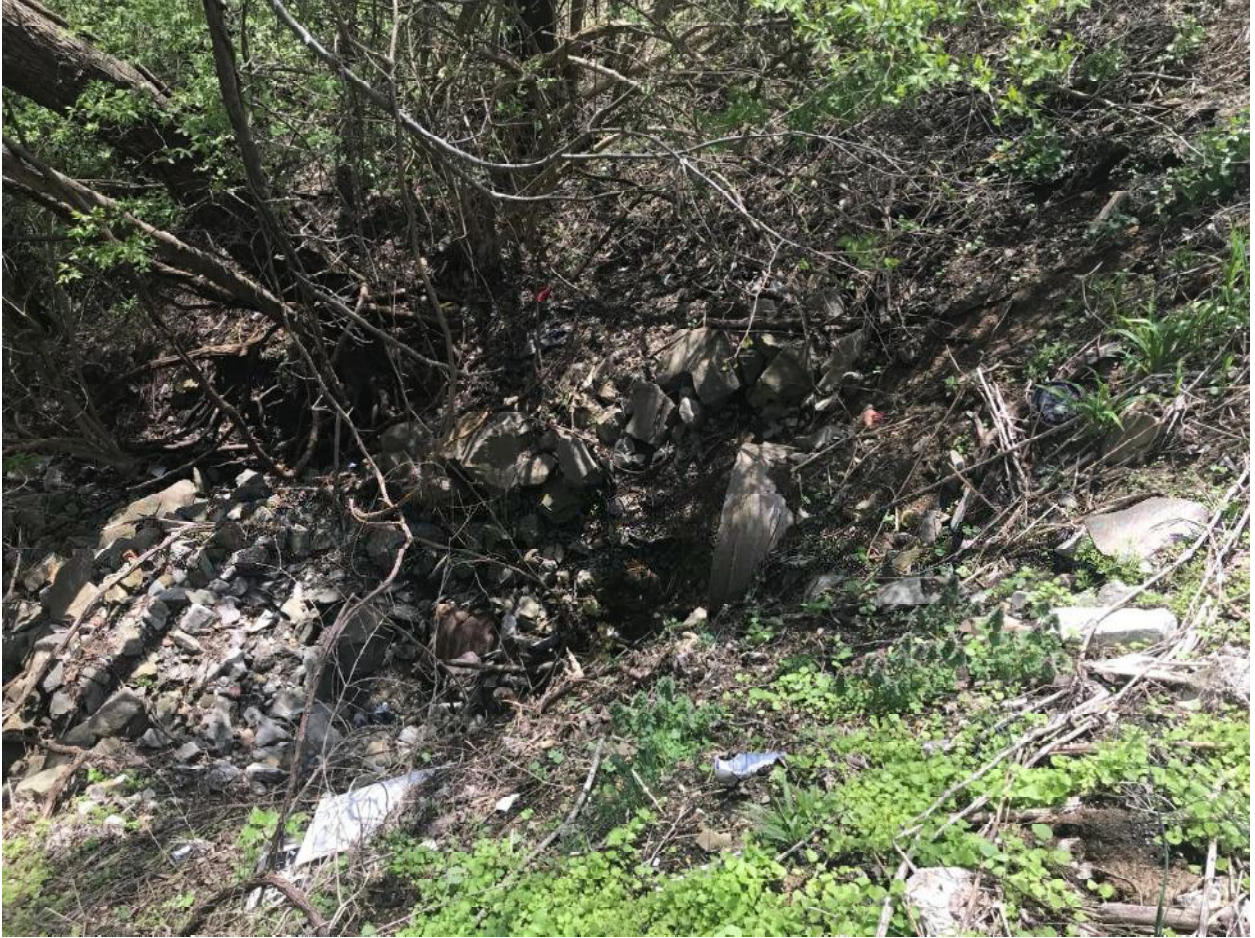
Outfall #2 of UNT to Speers Run along State Road

Outlets to the UNT to Speers Run along State Road near intersection with Pennsylvania Boulevard. Small trickle flow during inspection. Recommend performing future inspections in the spring prior to heavy foliage and marking the location of the outlet pipe with paint or PennDOT approved delineator paddles along State Road.

24" RCP

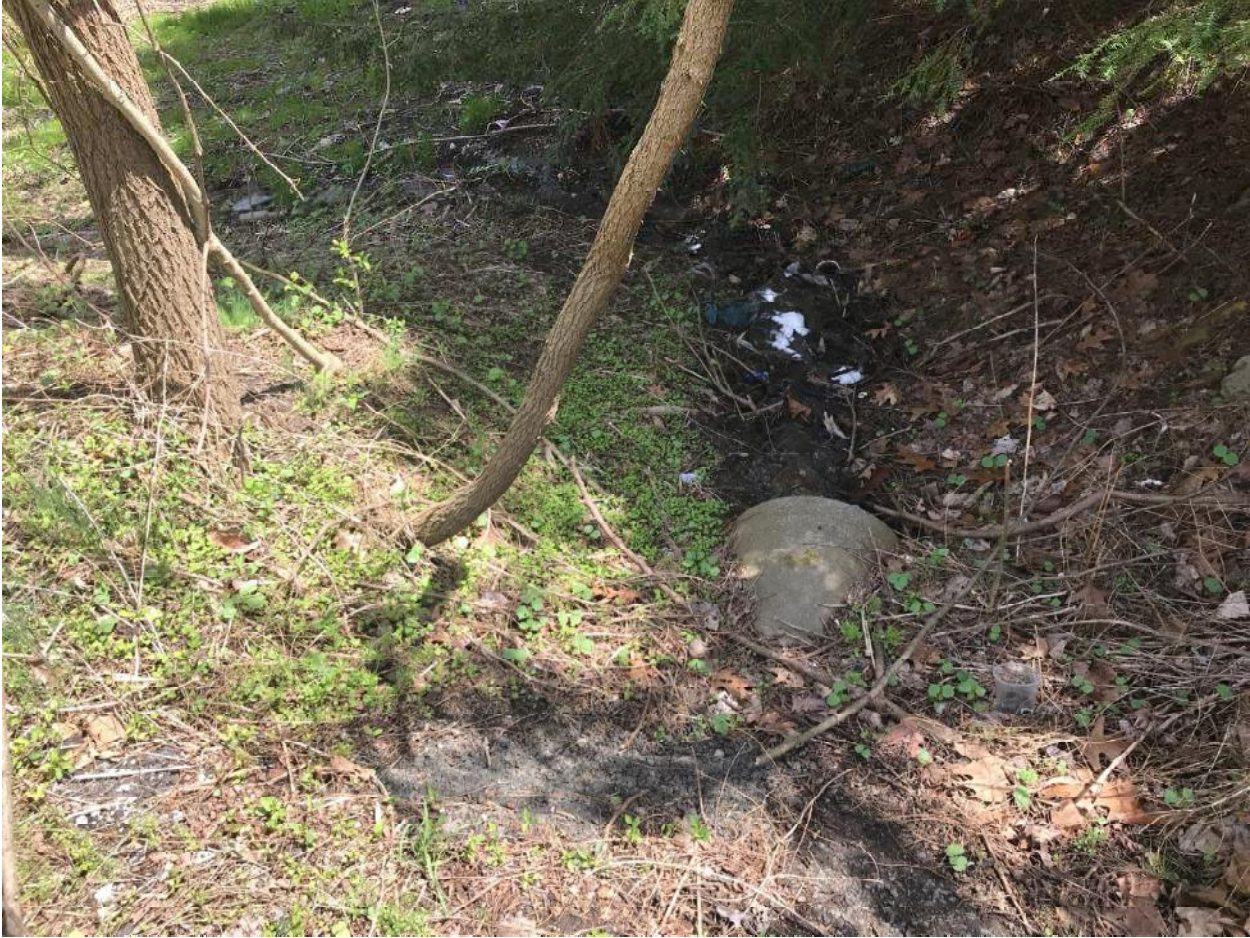
Outfall #3 of UNT to Speers Run along State Road

Outlets to the UNT to Speers Run along State Road below MVSA pump station building. Small flow during inspection. Flow is attributed to natural springs feeding the stormwater lines along Pacific Boulevard. Recommend performing future inspections in the spring prior to heavy foliage and marking the location of the outlet pipe with paint or PennDOT approved delineator paddles along State Road.

18" RCP

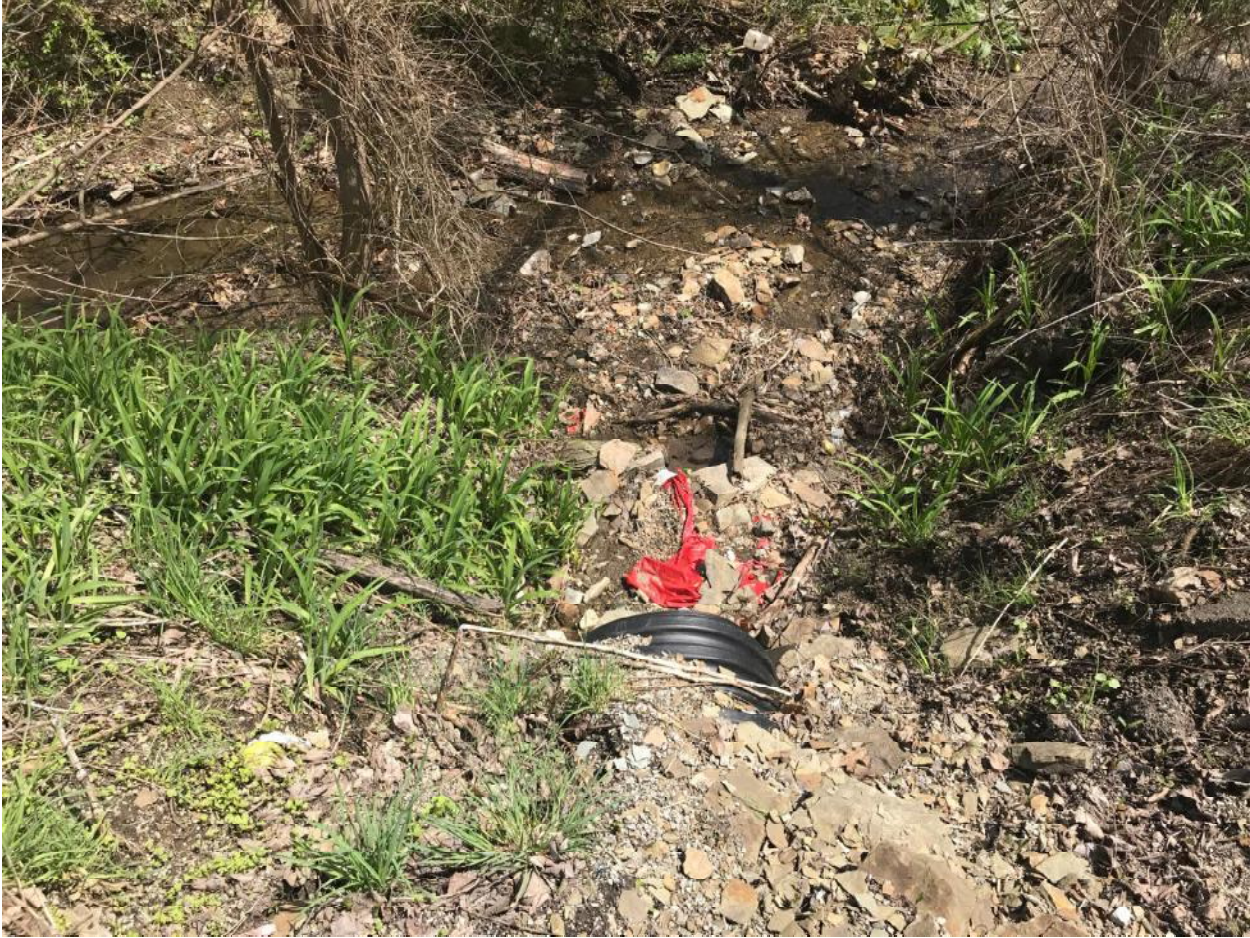
Outfall #4 of UNT to Speers Run along State Road

Outlets to the UNT to Speers Run along State Road. No flow during inspection. Recommend performing future inspections in the spring prior to heavy foliage and marking the location of the outlet pipe with paint or PennDOT approved delineator paddles along State Road.

24" CPP
